Technical Service Bulletin

MODEL(S) T300/T300e Walk-Behind Scrubbers
AFFECTED:

SUBJECT: Reduced battery run-time and/or BDI fails to display a full charge after a complete charge cycle.

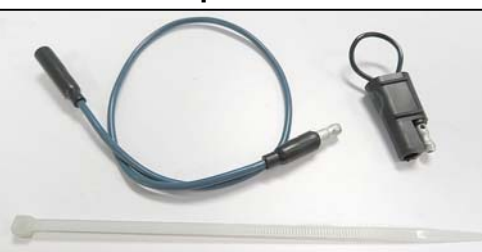
9017921 Jumper Kit Contents

* The kit contents will include either a wire harness jumper or a plug connector jumper as shown above. Both serve the same purpose.

Install Jumper Kit to repair issue:

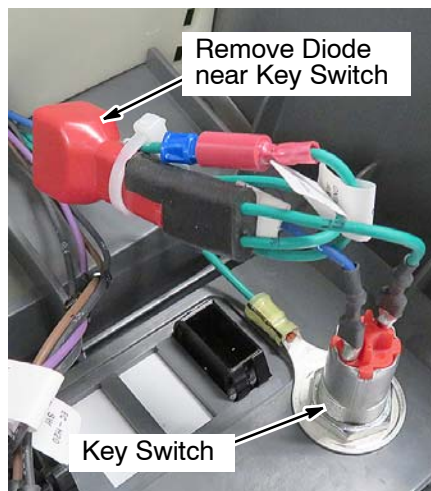
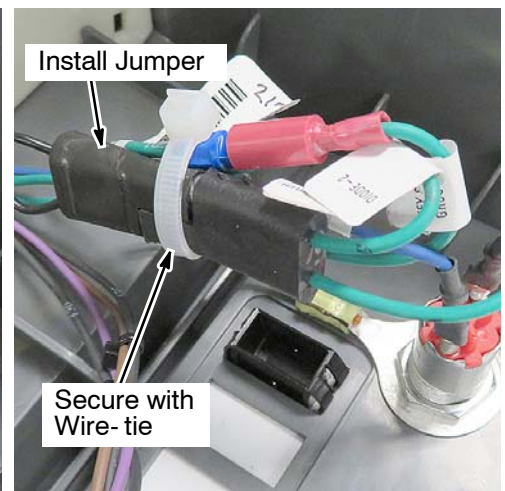
Root Cause: A diode was recently added to the wire harness to prevent potential control board failure if battery terminal connection is accidentally reversed. Reports claim the addition of the diode has caused a small voltage drop affecting the firmware to act as if the batteries are at a lower voltage.

PURPOSE: To repair the above issue, the diode must be removed and replaced with Jumper Kit 9017921 as shown below. As an alternative option to repair issue, the diode connector plug can be cut from the wire harness and replaced with a spade terminal also shown below.
