Technical Service Bulletin

MODEL(S) AFFECTED:	Speed Scrub Rider
SUBJECT:	Drive motor wires may need to be repositioned to avoid wire abrasion when making right and left hand turns. Inspect the wire harness for clearance and if necessary reposition the wires as described below.
PURPOSE:	To prevent the risk of drive motor failure.
NOTES:

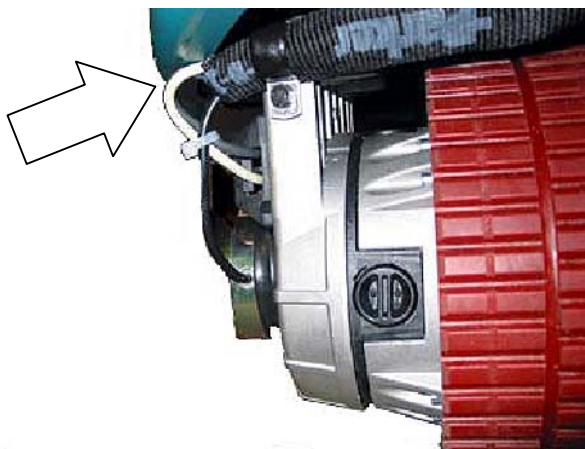
Abrasion point when making a left hand turn. Comes in contact with rotomold edge.

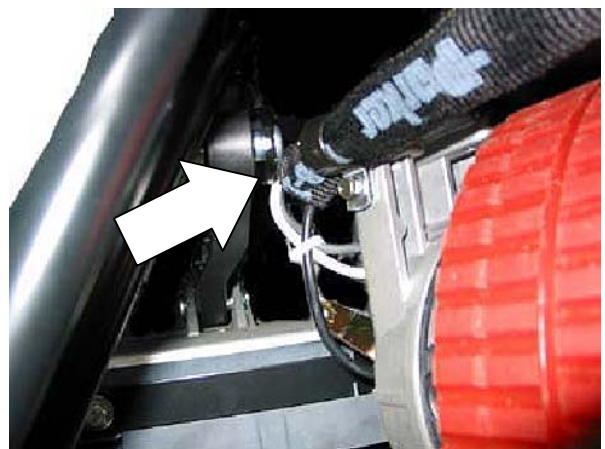
Abrasion point when making a right hand turn. Comes in contact with the scrub head pivot arm.
