Technical Service Bulletin

MODEL(S) AFFECTED:	T7 Rider Scrubber
SUBJECT:	Drive motor wires may need to be repositioned to avoid wire abrasion when making right and left hand turns. Inspect the wire harness for clearance and if necessary reposition the wires as described below.
PURPOSE:	To prevent the risk of drive motor failure.
NOTES:

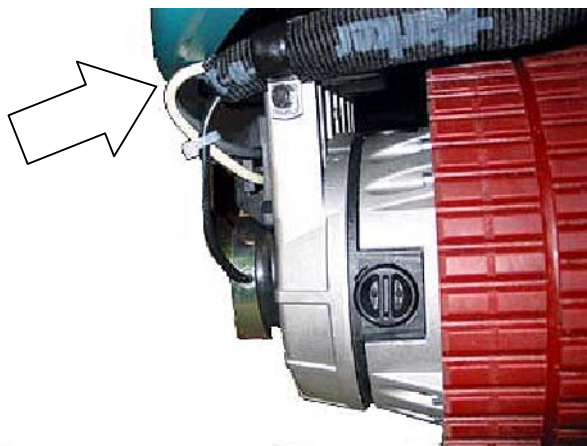
Abrasion point when making a left hand turn. Comes in contact with rotomold edge.

1. Loosen the two cable clamps and move the wire harness away from the abrasion points. Re-secure clamps.

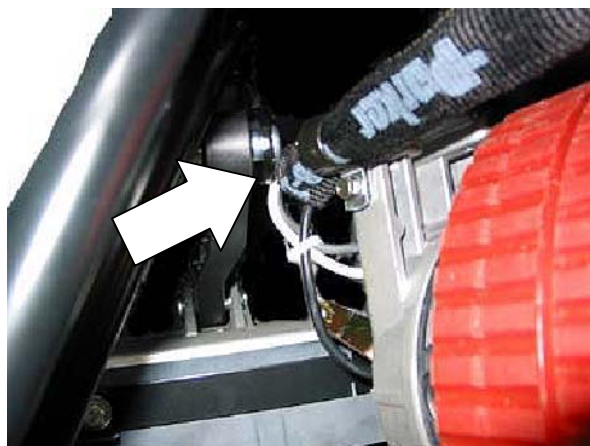
Abrasion point when making a right hand turn. Comes in contact with the scrub head pivot arm.
