Technical Service Bulletin

MODEL(S) AFFECTED: **Tennant 2510 and 2550 Floor Burnisher**

SUBJECT: Control Grip malfunction – If you have experienced the control grip switch(es) coming out of adjustment, a service kit is now available to resolve problem. The kit comes complete with 2 switches and new mounting hardware that will keep the switch(es) locked in the proper position.

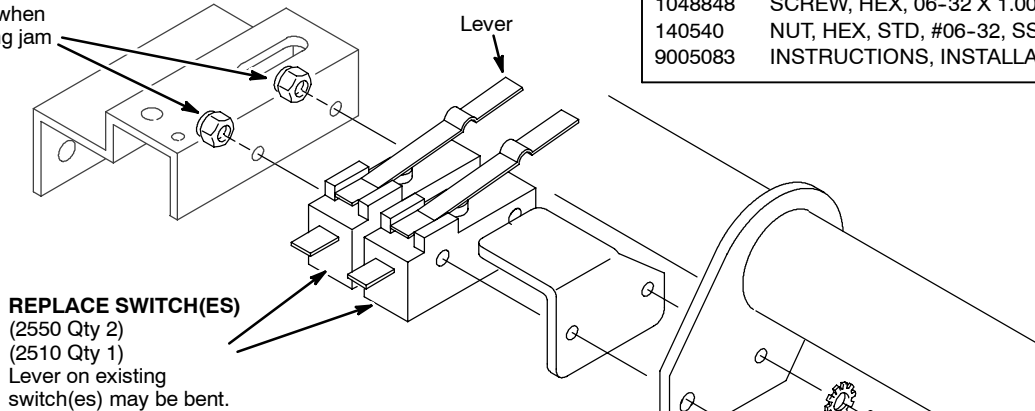
(2550 Qty 2)
(2510 Qty 1)
Lever on existing switch(es) may be bent.

JAM NUTS

(140540)
Hold Hex head screws when tightening jam nuts.

REPLACE SWITCH(ES)

Use existing Lock Washers

REPLACE WITH HEX HEAD SCREWS
(1048847 - 2510)
(1048848 - 2550)

Changing from Philips head screws to Hex head screws allows you to properly tighten.

Screw torque: 44lb-in/ 5Nm

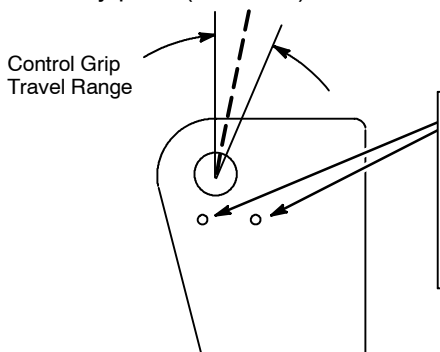
Side View of Control Console

PROPER SWITCH ADJUSTMENT

Switch(es) should activate (click) at the half way point (dash line).

To readjust the activation point, loosen the two screws below the control grip along with the rear hex head screw. After properly adjusting switches re-tighten screws.
