Technical Service Bulletin

MODEL(S) AFFECTED: Tennant T1, T1B, E5 and R3

SUBJECT: Recovery tank ball-float filter prematurely activates and/or machine has poor vacuum suction. This may be caused by the motor shroud not being positioned properly.

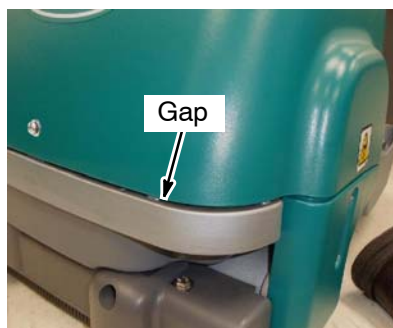
PURPOSE: If motor shroud is slightly raised as shown below, the tank gaskets will not form the proper seal with the solution tanks when cover is lowered.

Shroud not properly seated.
Gap can be as little as 1/16"
(1.5 mm).

When replacing motor shroud, make sure the shroud is completely resting on the frame. The vacuum exhaust muffler may prevent cover from being completely lowered. Before tightening screws, apply downward pressure on shroud to ensure proper installation.

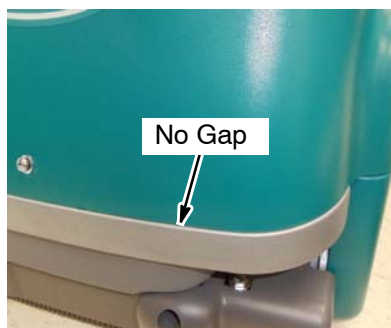
Shroud properly seated.

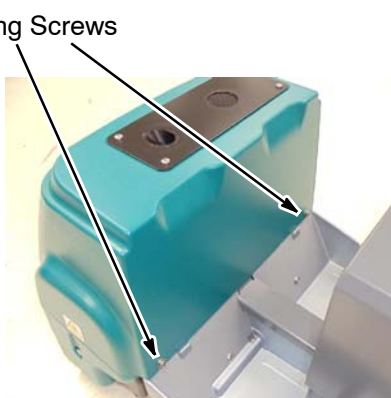
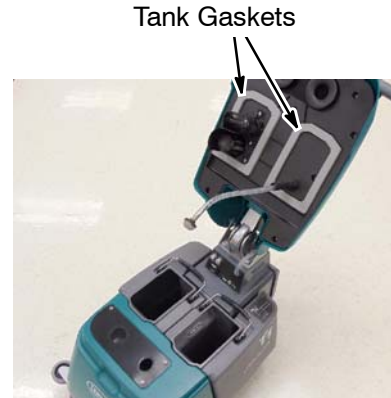
Tank Gaskets

1. Tanks may not be seated in machine properly.
2. Machine cover may be warped or not centered over tanks.
3. Tank gaskets may be worn or damaged.
