Technical Service Bulletin

MODEL(S) AFFECTED: Speed Scrub 17", 20" and 24" Models with Propel

SUBJECT: False Battery Discharge Indicator reading. If BDI charge level rapidly drops upon machine start up, the control board module may have a program error.
Note: The actual run time is not affected by false BDI reading, the batteries will continue to discharge as normal.

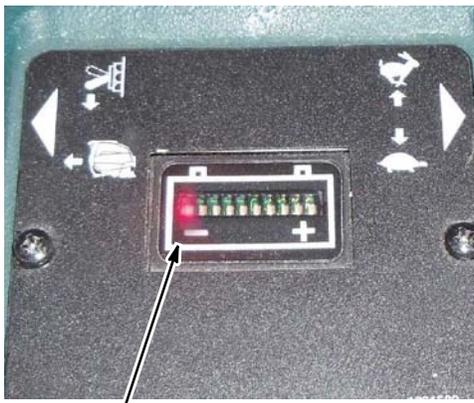
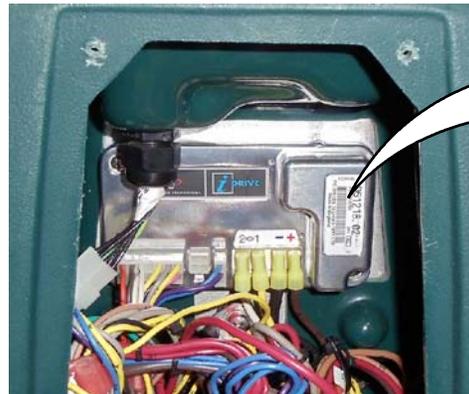
False BDI reading when batteries are fully charged. The actual run time is not affected by the false reading, the batteries will continue to discharge as normal.

Replace control board module with Revision 03.

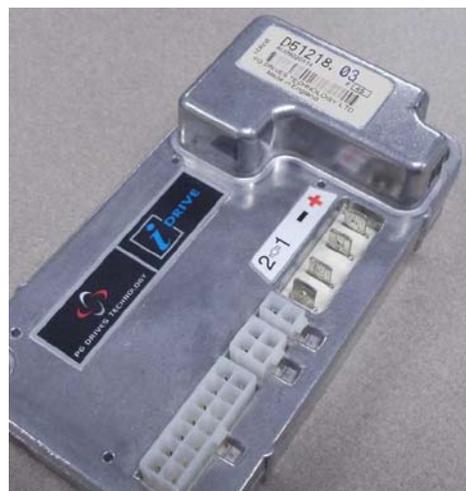
Replacement Control Board Module Rev. 03 (p/n 1052260).

Note: The revision level 03 may be hand-written due to existing inventory was reprogrammed.

PURPOSE: To correct the BDI reading, replace the control board module with revision 03 (p/n 1052260). The revision level is located on module's label as shown below.
