Technical Service Bulletin

**MODEL(S)
AFFECTED:****7100 Rider Scrubber**

SUBJECT:

Potential scrub head actuator damage. Due to a higher stall current with the Sir actuator, the control board program may not immediately detect the scrub head location. Instead of the scrub head going to start position at machine start up, it may force the scrub head downward which could cause damage to the Sir actuator over time.

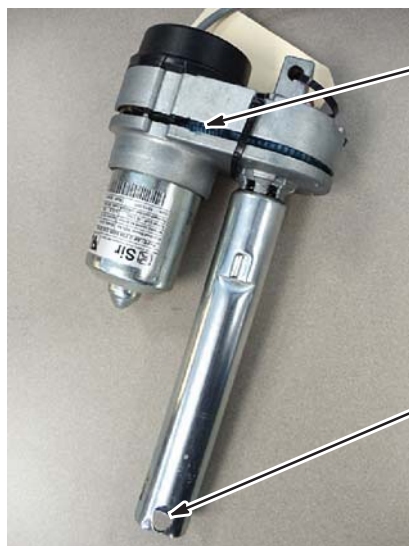
Sir Actuator (p/n 1053340)

Signs of damage from excessive scrub head pressure.

Actuator cover
pulling away
from motor.

Damaged
(elongated)
mounting hole
on shaft.

If you experienced the above condition, install control board (p/n 1014736) with latest program update (Software date code: 2/11/11).
