Technical Service Bulletin

MODEL(S) S5 and S9 Walk- Behind Sweepers

SUBJECT: Potential loss of main brush drive function due to pulley failure. If pulley is overloaded, the motor shaft may gradually strip out the square drive slot resulting in pulley failure.

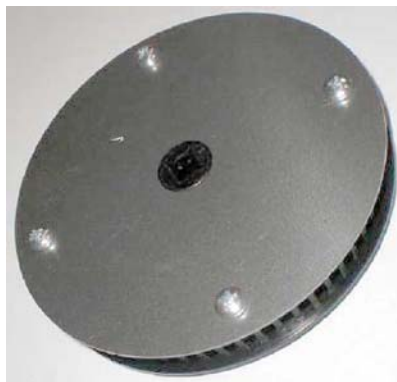
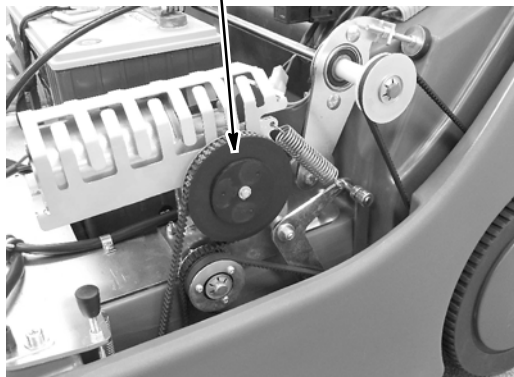
Upgraded Motor Pulley

PURPOSE: If you experience the above condition, install the upgraded motor pulley included in the following pulley kits. The upgraded pulley has been redesigned to withstand excessive overload. The material strength was increased, the motor shaft slot is tighter and the metal retaining plate was enlarged to add strength around the square drive slot.

S5 Pulley Kit: 9010170
S9 Pulley Kit: 9010165

IMPORTANT: Use a thread- locking compound to secure pulley screw.
