## Technical Service Bulletin

**MODEL(S) AFFECTED:** S9 Walk- Behind Sweeper  
Machines shipped before June, 2013.

**SUBJECT:** Potential loss of propel due to bail not functioning properly or bail not holding adjustment after belt tensioner bracket was properly adjusted.

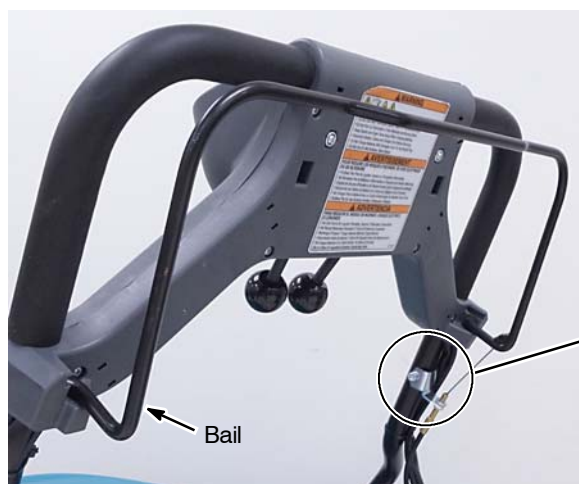
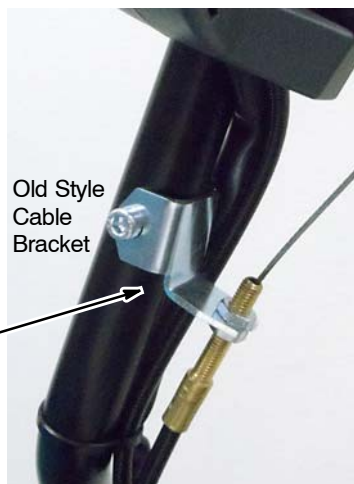
### Old Style Cable Bracket

**PURPOSE:** If machine is equipped with old style cable bracket (shown below) and you experience the above condition, order the upgraded bail and cable kit p/n 9010175. The kit includes the necessary parts to resolve the propel issue as described below.
