# Technical Service Bulletin

**MODEL(S) AFFECTED:** T300e, T2, T3 and T3e Single Disk Models with 3-lug drive hub design.

**SUBJECT:** Potential die cast aluminum drive hub failure (motor shaft bore cracking). This may be caused from stop pin engagement while scrub head is spinning, excessive force used to separate disk from hub, repeated start/stop cycling of scrub head, or motor stall conditions.

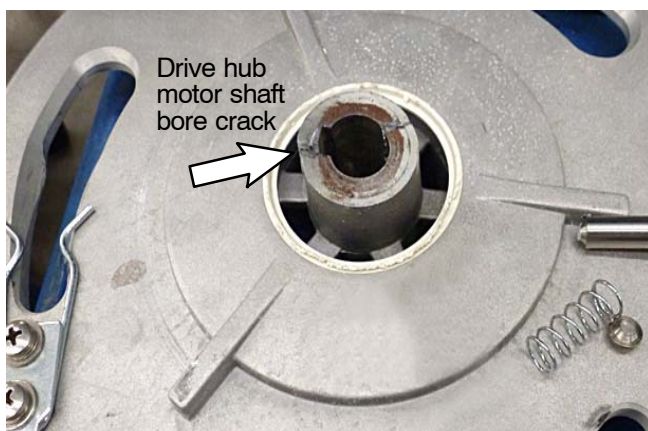
Die cast aluminum drive hub primarily cracks near keyway, also damaging motor shaft.

For field replacement of a failed die cast aluminum drive hub, order the New Injection Molded Drive Hub Kit p/n 9014623.
