# Technical Service Bulletin

**MODEL(S) AFFECTED:** **5680 models equipped with Drive module (PG Drives Technology)**

Models manufactured before serial numbers 10773023 (Nov 17, 2015)  
and 5680-U07158 (Nov 24, 2015).

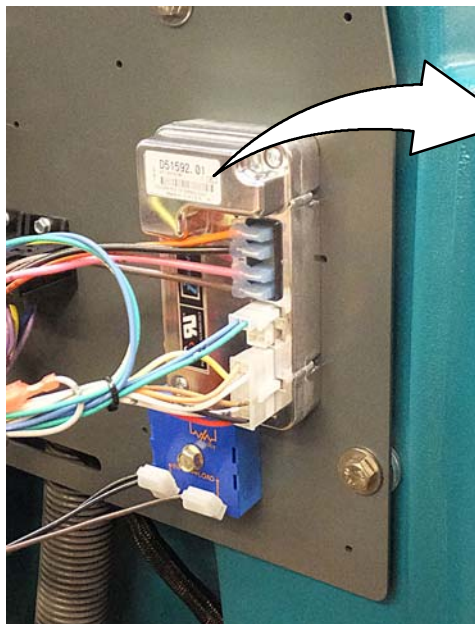
**Drive Module Program Revision Level**

**SUBJECT:** **Issue #1.** False Battery Discharge Indicator reading. If BDI charge level rapidly drops upon machine start up, the drive module may have a program error. The actual run time is not affected by false BDI reading, the batteries will continue to discharge as normal.

**Issue #2.** Transaxle motor can overheat when overloaded for an extended period.

**NOTE:** The above issues only apply to Drive modules with program revision 01.

**PURPOSE:** To resolve these issues, replace the drive module with program revision 02 or higher (p/n 1212548). The program revision level is identified on the drive module label as shown below.
