Technical Service Bulletin

MODEL(S) AFFECTED: T300/T300e Walk-behind Scrubber

SUBJECT: Disabled vacuum motor due to wire harness failure at squeegee lift bracket switch. Over time, as the squeegee lift bracket pivots from side to side, the squeegee lift bracket switch wiring may weaken and eventually break.

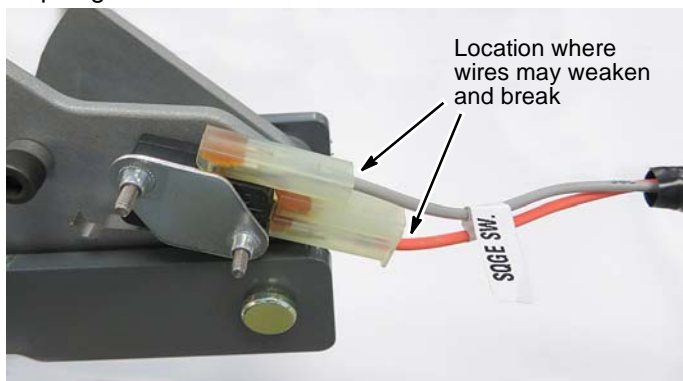
Squeegee Lift Bracket Switch wire harness connection

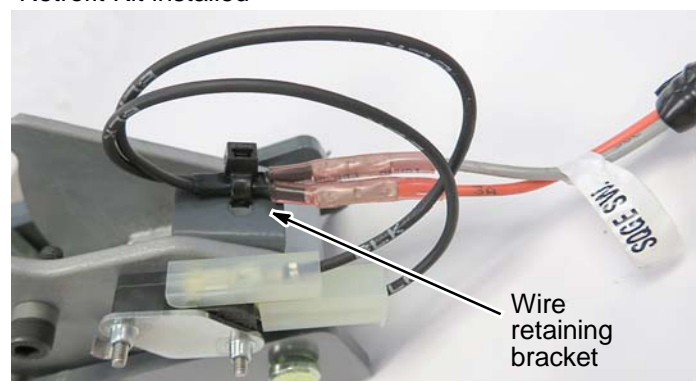
Retrofit Kit installed

PURPOSE: To repair or prevent wire harness failure, order retrofit kit 9016739. The kit is designed to retain the squeegee switch connector wire harness as shown below.
