Technical Service Bulletin

MODEL(S) AFFECTED: Speed Scrub 300 Walk-Behind Scrubber

Models manufactured between S/N SS300-10885160-10894861

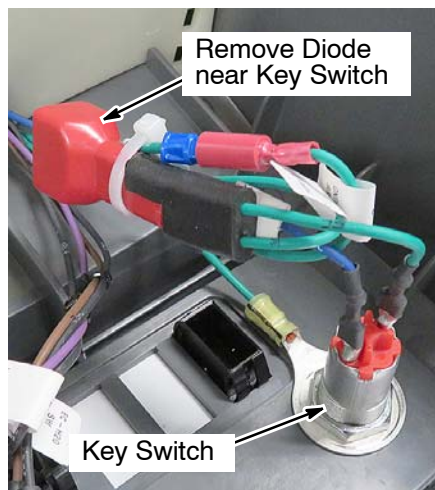
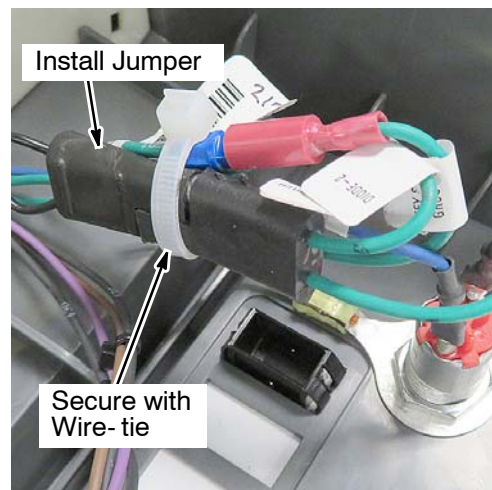
Install Jumper Kit to repair issue:

SUBJECT: Reduced battery run-time and/or BDI fails to display a full charge after a complete charge cycle.
 Root Cause: A diode was recently added to the wire harness to prevent potential control board failure if battery terminal connection is accidentally reversed. Reports claim the addition of the diode has caused a small voltage drop affecting the firmware to act as if the batteries are at a lower voltage.

PURPOSE: To repair the above issue, the diode must be removed and replaced with Jumper Kit 9017921 as shown below. As an alternative option to repair issue, the diode connector plug can be cut from the wire harness and replaced with a spade terminal also shown below.
