# Technical Service Bulletin

**MODEL(S) AFFECTED:** T500/T500e Walk-Behind Scrubbers

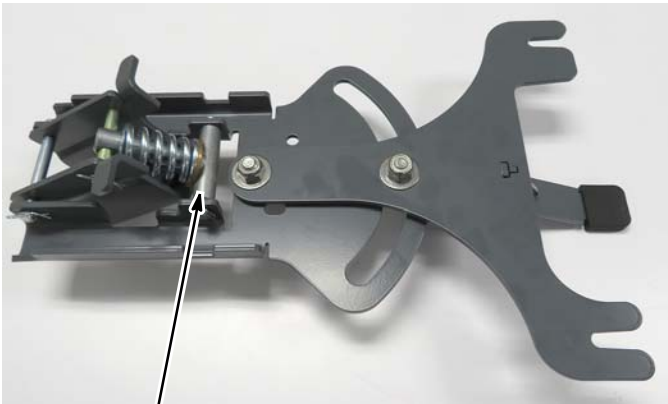
Squeegee Lift Bracket Spring Guide

**SUBJECT:** The bronze spacer located on the squeegee lift bracket spring guide may fail during normal operation over time. If spacer fails (cracks in half), the squeegee blade pressure that is applied to the floor will weaken and cause a reduction in solution pickup. The squeegee pedal may also fail to stay in the up position during transport due a failed spacer.

**PURPOSE:** To repair or prevent the above issue, order the Squeegee Bracket Spring Guide Kit 9016898. The new spring guide is designed to be used without a spacer.

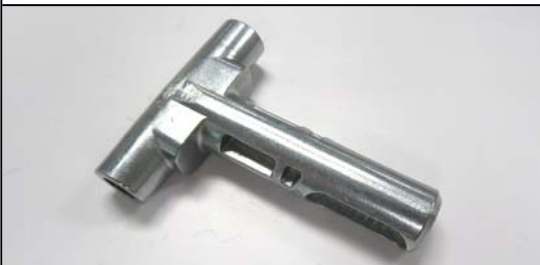
1235860 Spring Guide (no spacer required)  
9016897 Installation Instructions

**Kit Installation Note:** The squeegee lift bracket must be removed from the machine in order to relieve tension on spring for spring guide removal. Follow the installation instructions supplied with kit.

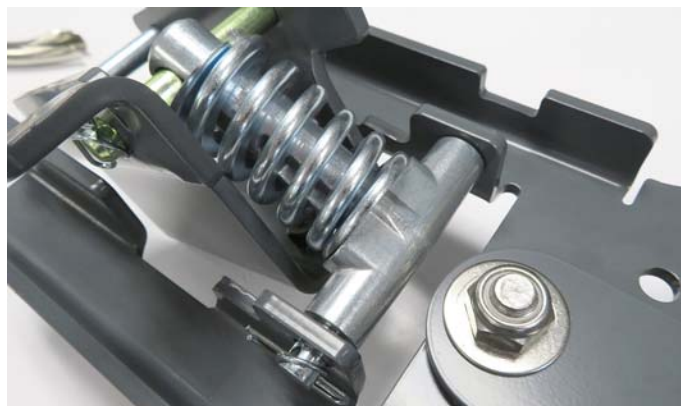
**Manufacturing Note:** As an interim upgrade prior to implementing the new spring guide into production, two stainless steel washers that equal the same thickness of the bronze spacer (to maintain the proper spring retention) were used as a replacement.
