## Technical Service Bulletin

### MODEL(S) T350 Stand-on Scrubbers

**AFFECTED:** Models manufactured in N. America before S/N T350-10897605 (April 9, 2018)  
Models manufactured in Europe before S/N T350-U00186 (August 17, 2018)

**SUBJECT:** On-board battery charger failure due to potential voltage backfeed when reconnecting the double-pole battery cable connector. Machine fault code "0xF103"/"●●●●●●●●" (Charger CAN communication fault) will be detected.

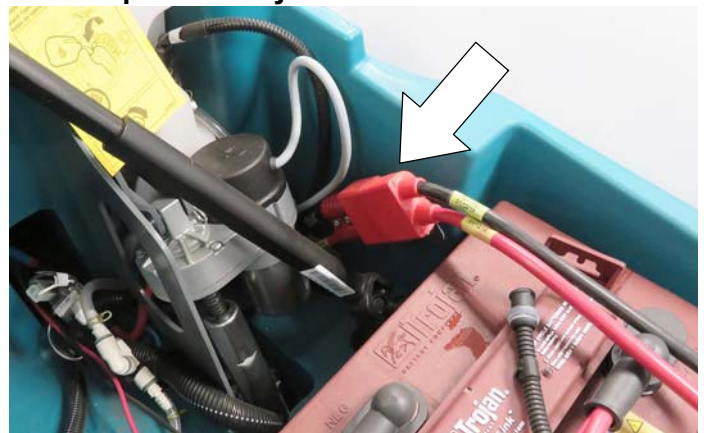
**Affected machines are equipped with double-pole battery cable connectors.**

**PURPOSE:** To repair a failed battery charger caused from voltage backfeed, order Battery Charger Retrofit Kit p/n 9017891. The retrofit kit includes the necessary parts to rework the battery cable configuration with single-pole battery connectors to prevent future battery charger failure.

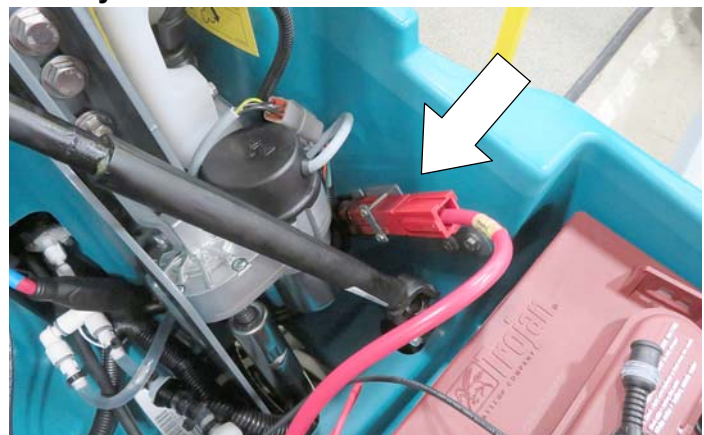
**Picture of reworked machine with single-pole battery cable connectors.**
