Technical Service Bulletin

B5, B7, T300e, T300, T500e, T500, T600e and T600 N. America Models manufactured before April 23, 2019 EMEA Models manufactured before April 18, 2019

SUBJECT:

Speed control potentiometer failure. Over time, under normal operating use, the potentiometer's adjustable wiper may slowly wear the printed resistive strip due to vibration causing intermittent or

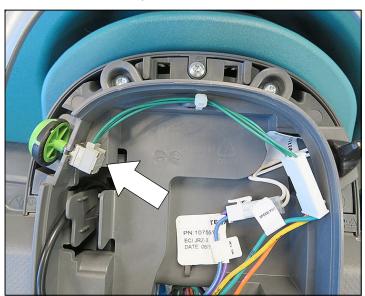
New Potentiometer (p/n 1246392)

The new potentiometer is a direct replacement. It does not require any specific installation instructions. The wires on the new potentiometer are all black whereas the original potentiometer are green.

To repair potentiometer failure, order replacement potentiometer (p/n 1246392). The new potentiometer is more robust and designed with 11 distinct speed settings, making it easier for the operator to select a desired speed by the feel of each speed detent of the dial. The 11 distinct resistive settings are silver pads which provide a longer wear life.
