Technical Service Bulletin

MODEL(S) AFFECTED: T7 AMR Autonomous Rider Scrubber

SUBJECT: Off-board charger interlock switch failure (i.e. damaged or loss of adjustment). The failure may occur if the

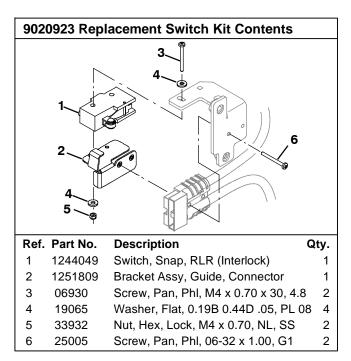
Before Kit Installed

charger connector is roughly connected or disconnected to and from machine. Switch failure will prevent

machine from powering up.

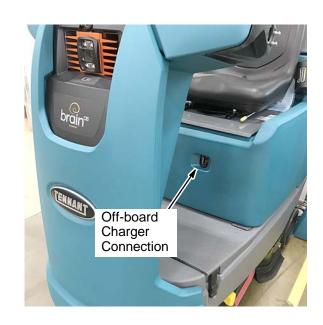
After Kit Installed

The kit includes a guide connector bracket to protect switch from failure as shown below.

PURPOSE: To prevent potential interlock switch failure, install Replacement Switch Kit 9020923.
