Technical Service Bulletin

MODEL(S) AFFECTED: **M17 (NA S/N 000000-012000 / European S/N U00000- U00562) / T17 (NA S/N 000000-014000 / European S/N U00000- U01338)**

SUBJECT: Firmware update reduced drive wheel output to increase reliability. Drive wheel output can be increased for customers who need it increased to previous output.

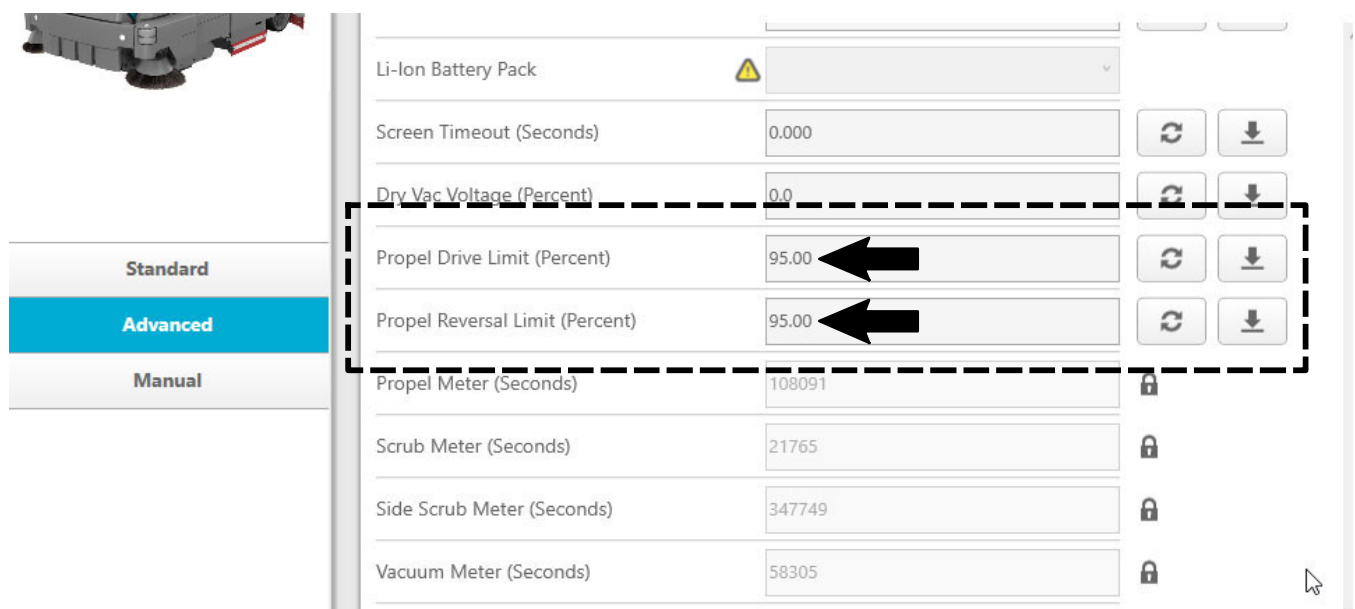
Fig. 1

NOTES: Through a previous firmware update, the M17/T17 drive wheel maximum allowable output was reduced from 100% to 95% to improve drive wheel gearbox reliability. Even with reduced maximum output, the machines still perform to specifications. It is recommended to leave the drive wheel output settings at 95%, unless a specific machine performance issue is observed by the customer.

Follow instructions in *RECONFIGURING THE MACHINE AFTER NEW HARDWARE/OPTION INSTALLATION* to access Propel Drive Limit (Percent) and Propel Reversal Limit (Percent) in the Advanced configuration screen and change the output from 95.00% to 100.00%. (Fig. 1)

NOTE: The Propel Drive Limit (Percent) and Propel Reversal Limit (Percent) must be the same output. Adverse performance could occur if the Propel Drive Limit (Percent) and Propel Reversal Limit (Percent) not the same.
