Technical Service Bulletin

MODEL(S) AFFECTED: B5 propel, B7, T300/e propel, T500/e, T600/e, SpeedGleam 5 propel, SpeedGleam 7, Speed Scrub 300 propel and Speed Scrub 500
N. America models manufactured before April 12, 2021.

SUBJECT: Speed Control potentiometer failure. Over time, under normal operating use, the potentiometer may exhibit a brief open-circuit condition and cause a propel fault. The detected fault will automatically put the i-Drive in the slow, safe mode or even cause complete propel failure. A simple key-cycle may clear the fault temporally, however the fault can reoccur when adjusting speed dial.

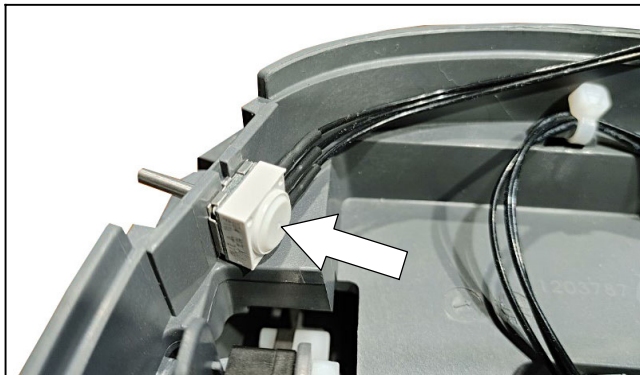
New Replacement Potentiometer p/n 1256757

The new potentiometer is a direct replacement and does not require any specific installation instructions. To identify the difference between the previous potentiometers, the body on the new potentiometer is thinner.

PURPOSE: To repair potentiometer, order replacement potentiometer (p/n 1256757). The new potentiometer is designed with a ceramic-based resistance element for long term durability. It's also designed without speed setting detents, therefore the speed control dial will feel different to the operator.

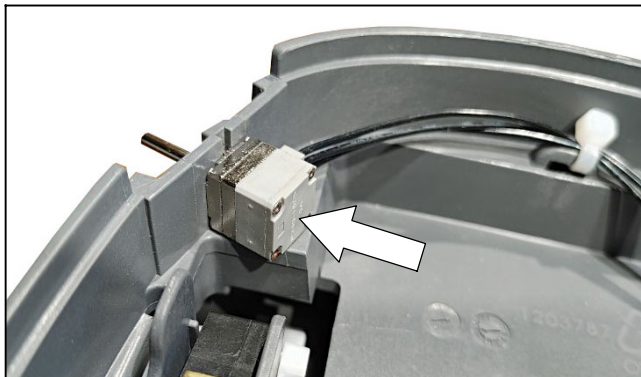
p/n 1246392

Previous Potentiometers (Discontinued)

NOTES: **Warranty Information:** Standard warranty terms apply. If you have any existing inventory of the previous potentiometers, it is advised to scrap them out and reorder the new replacement part.
