## Technical Service Bulletin

### MODEL(S) T581 Rider Floor Scrubber

**SUBJECT:** Potential propel power failure due to faulty wire harness connection.  
Small red wire pulling out of battery cable connector due to stress on wires.

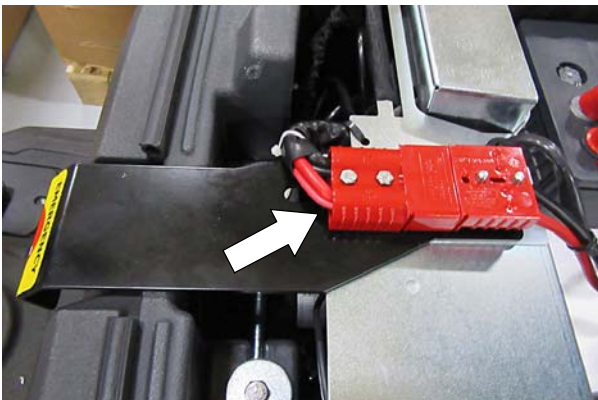
### Faulty Wire Harness Connection

1. Inspect wire connection below. If wires are stressed, adjust harness as described.
2. If wire is pulled out or loose, repair connection and adjust harness to relieve stress on wires.
3. Replace connectors as needed.
