Release Date:
September 7, 2022

Technical Service Bulletin

MODEL(S) AFFECTED: **S16 (Machines equipped with non-telemetry capable boards only - Machines equipped with telemetry/telemetry capable boards do not require this update)**

SUBJECT: Machine losing UI (User Interface) board function, preventing sweeping, vacuum fan, and all other functions other than Propel from operating. All membrane assembly LED lights will be nonfunctional.

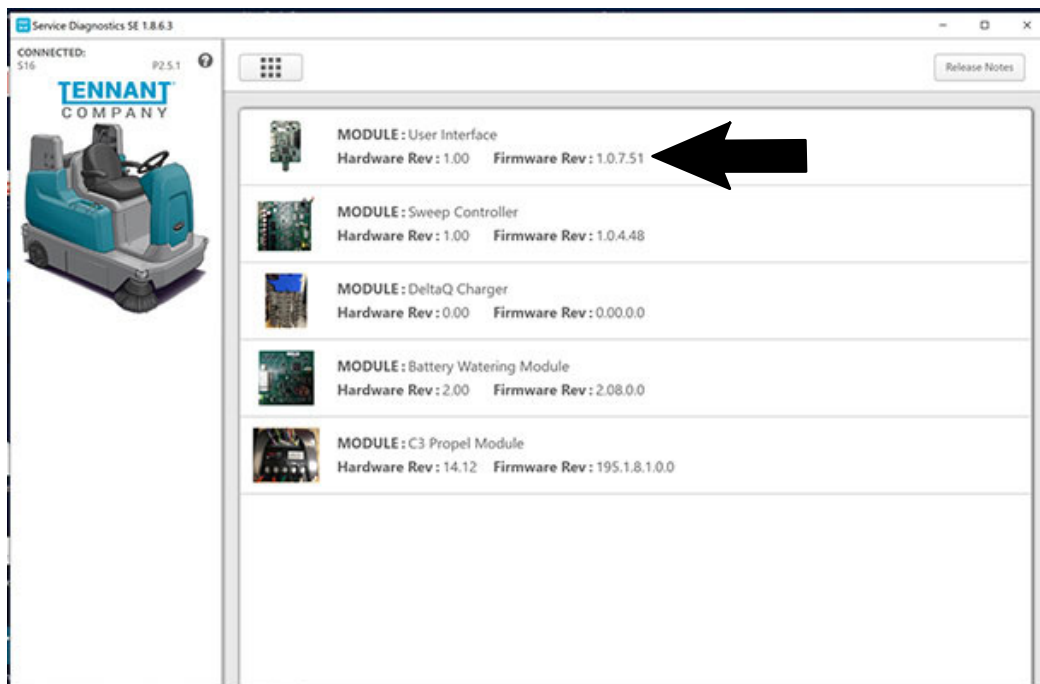
1. Determine machine Firmware Rev (firmware revision) through Service Diagnostics SE - Firmware Rev should be revision 1.1.6.66 or later.
