Technical Service Bulletin

MODEL(S) AFFECTED: **T391** - North America Market
Models manufactured before production date: May 2024

SUBJECT: A common issue has been identified where machine may not pick up water as expected. After evaluation, if the left and right squeegee blade retainer straps are inadvertently installed upside down, the straps will prevent the blades to properly deflect (bend at a 45° angle as shown below) to obtain optimum pick up performance.

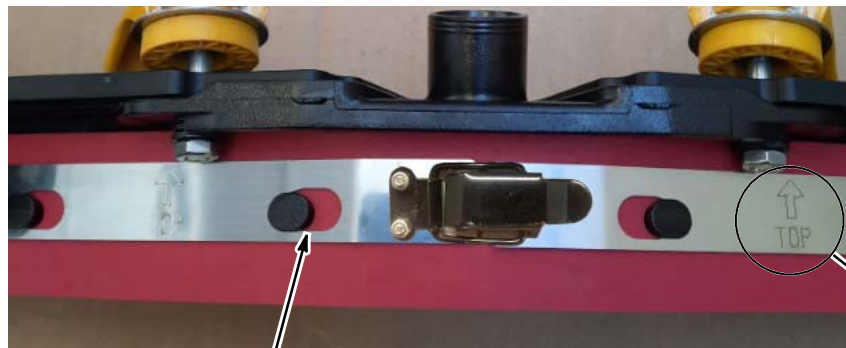
Squeegee blade retainer straps properly installed

PURPOSE: To resolve issue, simply install the straps according to the installation instructions described in the operator manual, also as shown in photo below.

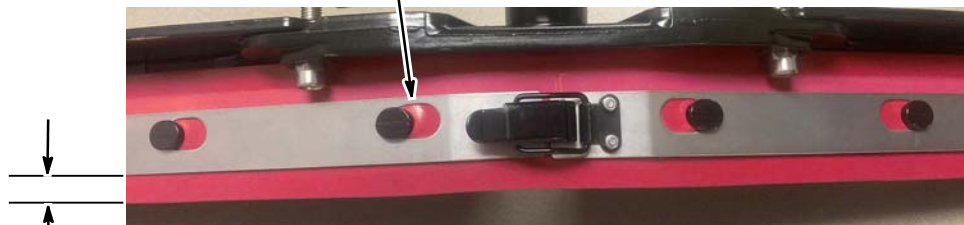
Note: The slots in the strap are vertically off-centered. If the straps are installed upside down, the strap moves closer to the floor as shown below, restricting proper blade deflection.

Squeegee blade retainer straps installed incorrectly (upside down)
