## TECHNICAL SERVICE BULLETIN 98800-012

## TITLE: PROPELLING MOTOR MOUNTING HARDWARE REPLACEMENT

APPLICABLE MACHINES: 800,810

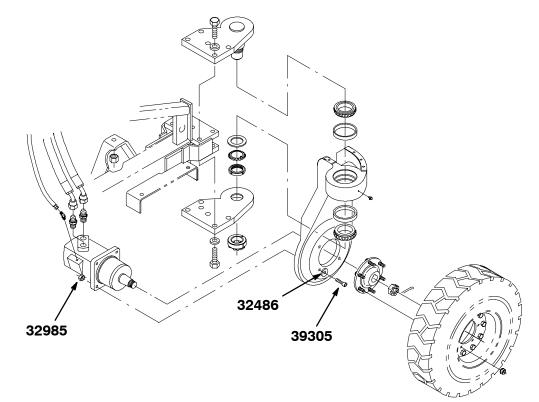
The hardware that mounts the motor to the Drive Support may loosen and need to be retorqued or replaced.

- 1. Jack the rear of the machine up to take the weight off the rear wheel. Place jack stands under each corner and then check the 4 mounting screws that mount the motor to the drive support.
- 2. If the hardware that mounts the propel motor is M12–1.75 x 70 hex head screw, they should be replaced with the following hardware:
  - (4) socket head cap screws 1/2"-13 x 2.75 (p/n 39305)
  - (4) 1/2" SAE flat washers (p/n 32486)
  - (4) hexlocnyln nuts 1/2"-13 (p/n 32985)
- 3. Once installed, torque to 90–110 ft.lbs. If existing hardware is already the cap screws, re-check the torque and correct if necessary.
