TECHNICAL SERVICE BULLETIN

No. 988410-002
Machine:8410
System:Engine Gas/LP

LRG 2.3L DIS ENGINE PERFORMANCE PROBLEM

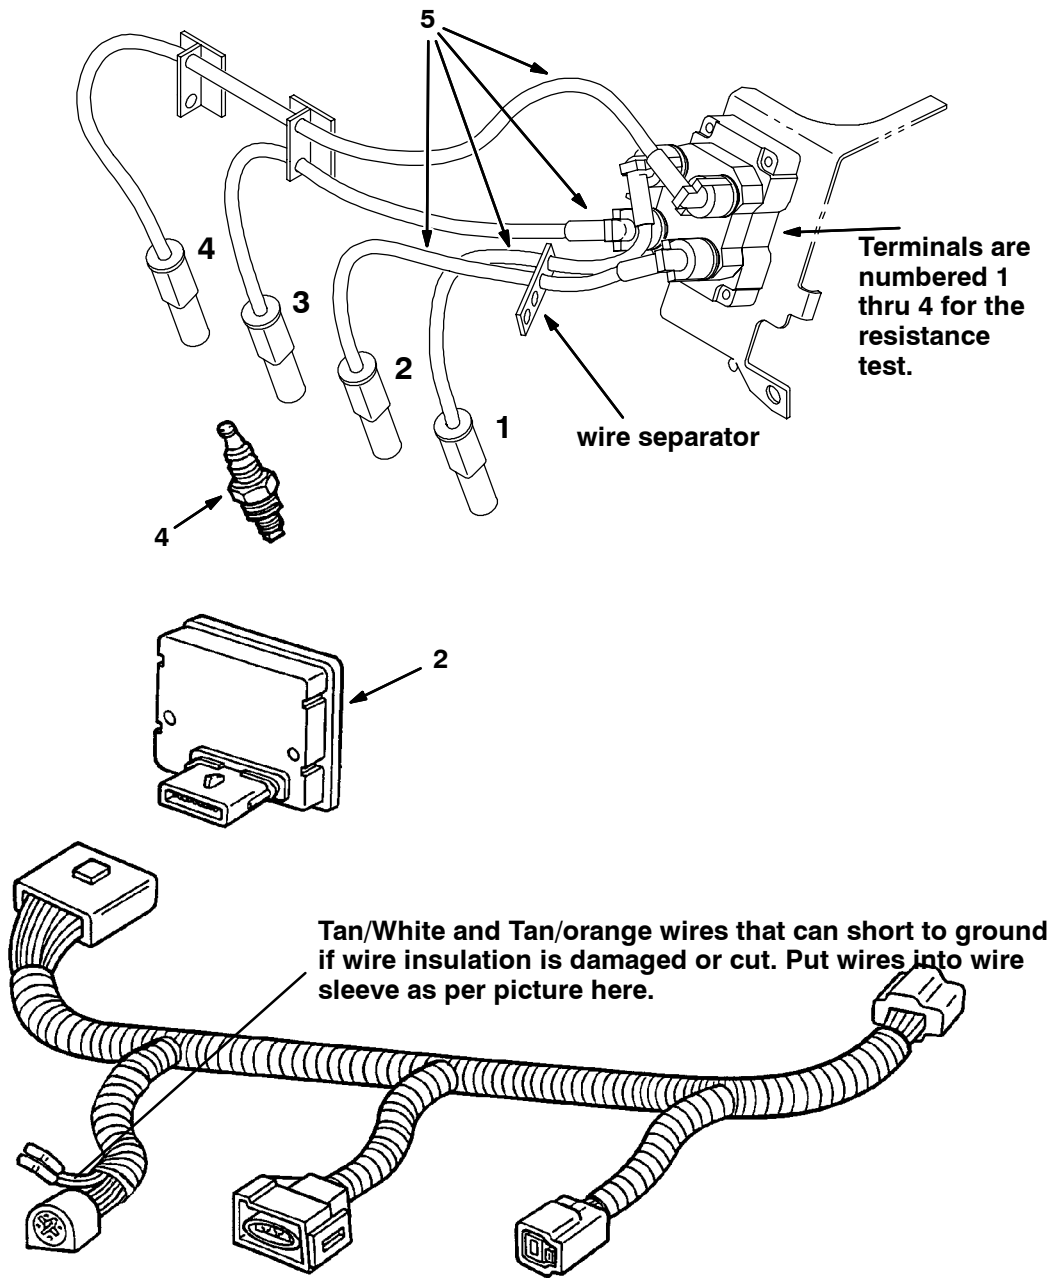
Fig. 1

1. The tan/orange wire or the tan/white wires that go from the engine spark control unit to the coil pack have rubbed against a sharp edge on the engine block and allowed the wires to short to ground.

2. If the spark plug wires are touching the upper radiator tube they may arc to each other over time and rubbing will cause the coil pack to fail.

1. In regards to cause number 1 above: Tie the wires away from the engine cover or put the wires in the wire harness sleeve and replace the coil pack if needed. New machines in production now have the wires protected by the wire harness sleeve.

2. In regards to cause number 2 above: Ford engineering has advised to make sure the spark plug wires are kept away from the upper radiator tube (see attached page for wire routing) and that a wire separator is used to keep plug wires away from each other. If you need a plug wire separator order part number 84882 .
