No. 211

Date: March 18, 2016

Technical Service Bulletin

MODEL(S) AFFECTED: Speed Scrub 300 (SS300) and Speed Scrub 17-20 (SS3) Single Disk Models with 3-lug drive hub design.

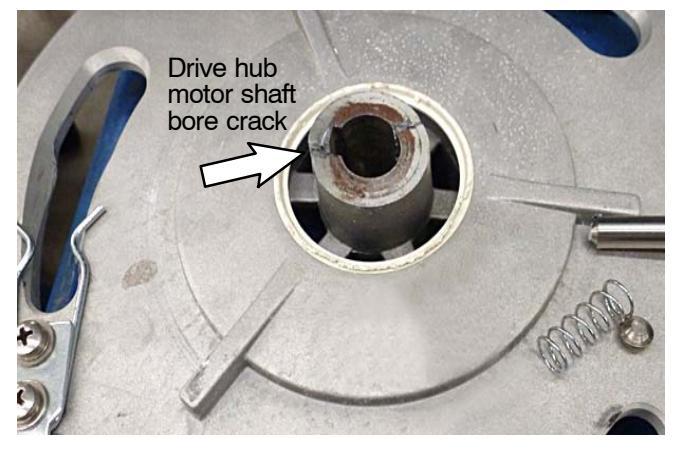
- **SUBJECT:** Potential die cast aluminum drive hub failure (motor shaft bore cracking). This may be caused from stop pin engagement while scrub head is spinning, excessive force used to separate disk from hub, repeated start/stop cycling of scrub head, or motor stall conditions.
- **PURPOSE:** Due to the failure rate, the die cast aluminum drive hubs will be phased out of production and replaced by a new and improved injection molded drive hub.

Die cast aluminum drive hub primarily cracks near keyway, also damaging motor shaft.

For field replacement of a failed die cast aluminum drive hub, order the New Injection Molded Drive Hub Kit p/n 9014623.
