Technical Service Bulletin

MODEL(S) T12 / T16 / T17 / M17 / S16 / 6200

SUBJECT: Threaded power connections can loosen over time, causing voltage drops and potential damage to electrical components.

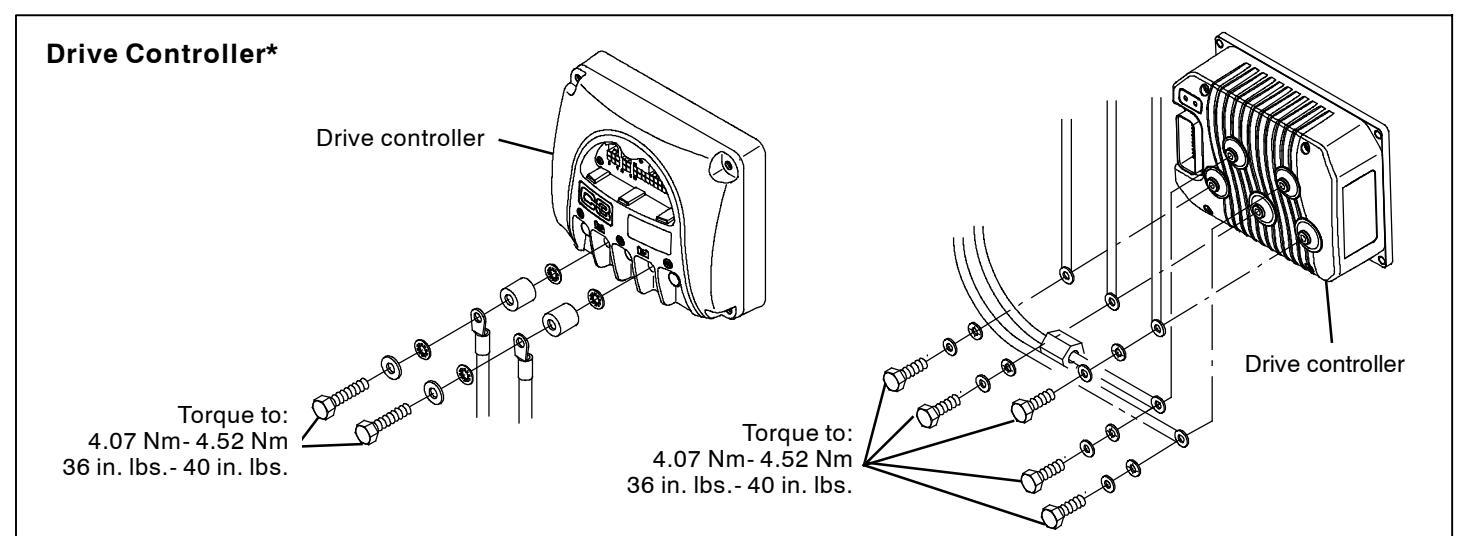
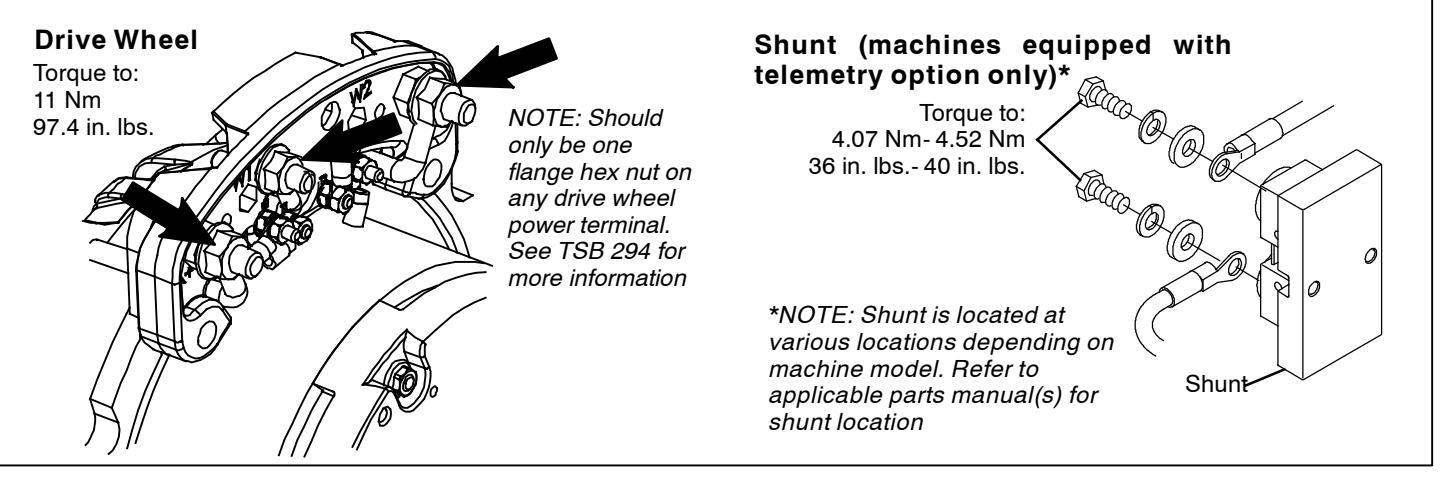
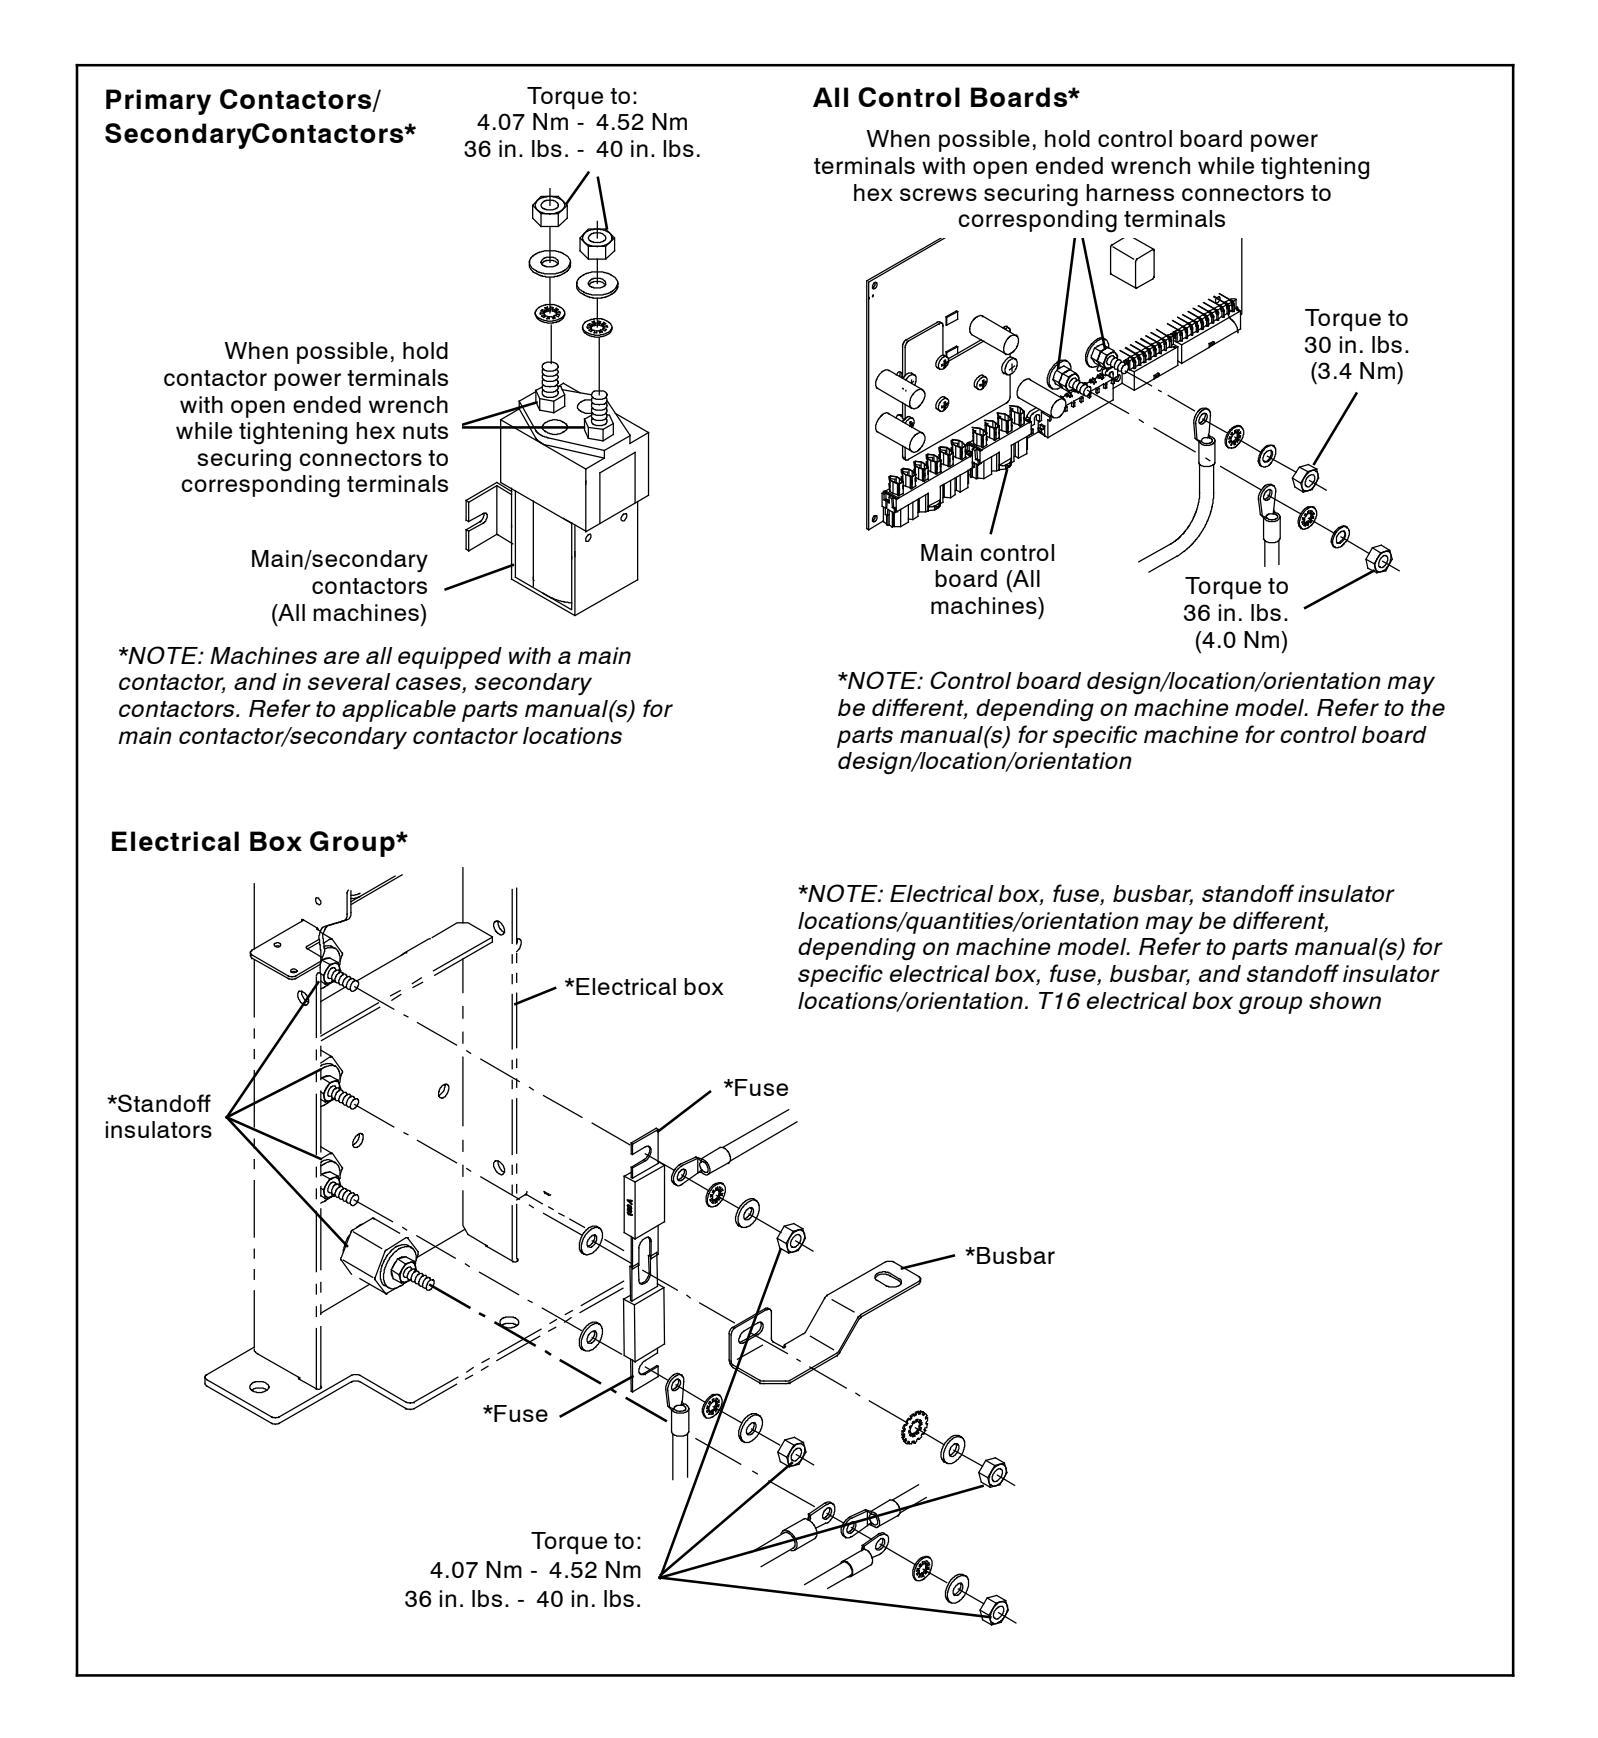
All ring connectors should be flat, tight with no gaps between the stacked connectors/hardware. The ring connectors must not be bent. A bent connector could possibly break. Replace the cable if the ring connector is bent.

*NOTE: Drive controller is located at various locations depending on machine model. There are also two drive controllers available, depending on age of machine. Refer to applicable parts manual(s) for drive controller model and location

PURPOSE: Machine vibration and other environmental factors can cause threaded power connections to loosen. All threaded power connections must be regularly retorqued to ensure connections are secure after the initial 50 hours of machine operation, and then retorqued again every 200 hours after the initial first 50 hours.

If there are loose connections, inspect components for possible damage due to excessive heat caused by loose/disconnected cable connection. Replace damaged components.
