Technical Service Bulletin

SUBJECT: Functional issue with emergency stop button (Design B). When pressed, the button may not remain engaged in the lock-out position as designed. In this condition, the switch will still disable machine when pressed, but the button must be held for one to two seconds on some models such as the Speed Scrub 24/32 (SS5), Speed Scrub Rider and Strive Rider.

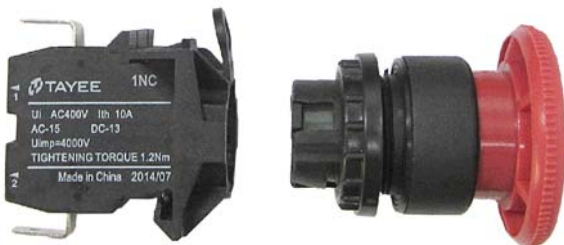
Replace with Emergency Stop Button, p/n 1011735 (Design A)

Note: Both emergency stop button designs share the same part number, confirm correct design before installing. Emergency stop button (Design B) has been removed from inventory.
