Technical Service Bulletin

**MODEL(S)
AFFECTED:****Tennant R14**

SUBJECT:

Solution Hose failure - Reports have been received that the solution hose routed to the solution tank fitting is splitting or bursting (see location below).

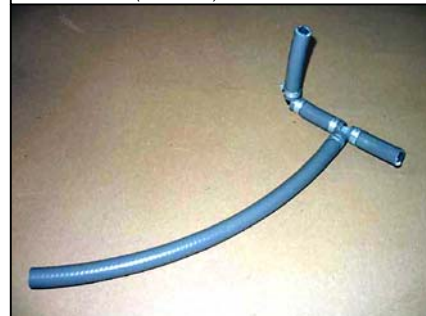
Part No.	Description	Qty.
9003385	Hose Assembly	1
54333	Clamp, Hose, Wormdrive	3
(not shown)

To repair or to prevent potential hose failure, install Solution Hose Kit p/n 9003386. The kit is designed to reduce the stress at the fitting connection, plus the hoses are rated for higher pressure.
