## Technical Service Bulletin

**MODEL(S) AFFECTED:** **Tennant M20 (machines serial number 000000-002247)**

**SUBJECT:** Hopper screen could get plugged when the machine is operated in extremely dirty environments, possibly causing the hopper to fill with water. Floating debris could clog the squeegee hoses, preventing the machine from picking up water when scrubbing.

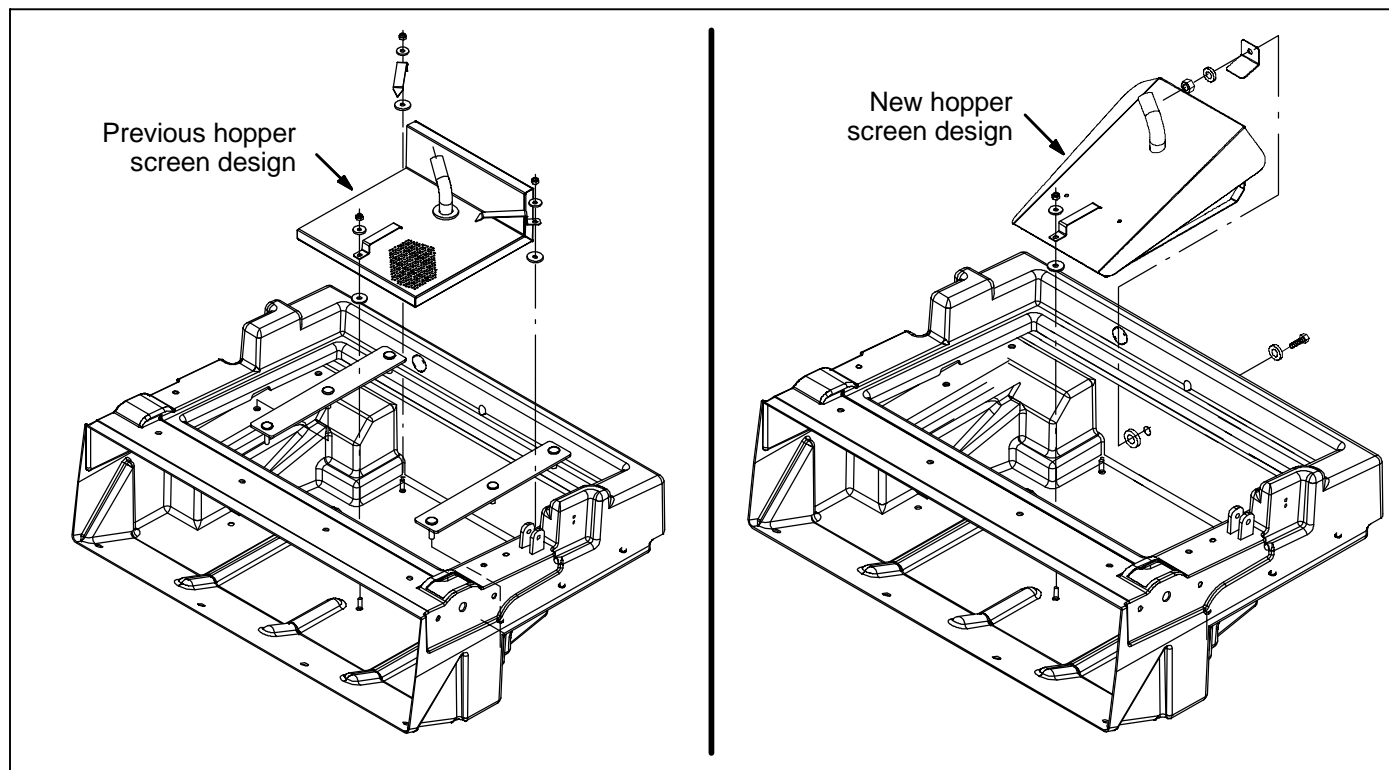
**PURPOSE:** Replace existing hopper screen with new hopper screen. New hopper screen is easier to clean and less likely to become clogged.

**NOTES:** Kit number 9003774. The Instruction Bulletin for this kit is IB 340863.  
Refer to IB 340863 for instructions how to properly install the new hopper screen.  
**NOTE:** To ensure proper operation, rinse all debris from the squeegee hoses when cleaning the hopper screen.  
Questions, contact the Tennant Customer Service Department at (800) 553-8033 or (763) 513-2850.  
**Warranty Information:** Standard Terms Apply.
