Technical Service Bulletin

MODEL(S) **Tennant T7 Rider Scrubber** AFFECTED:

SUBJECT: Potential brake wire failure. The brake wire harness (shown below) is designed to move freely with the drive wheel when turning machine, however a few field reports have experienced broken brake wires possibly caused from repetitive hard sharp turns. If brake wires break during machine operation, the machine will automatically activate the brake preventing machine from moving. The propel system fault alarm will repeatedly beep 7 times.

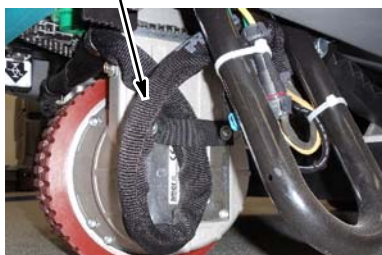
Brake Wire Harness

BEFORE serial number:
10518139 / T7xxx05316 (Europe)

The brake wires, shown below, are routed through the harness sheathing.

PURPOSE: To repair or prevent brake wire failure, install Brake Jumper Kit p/n 9008400. This kit is designed to replace the brake wire leads that are connected directly to the main machine harness with a high flex jumper harness.

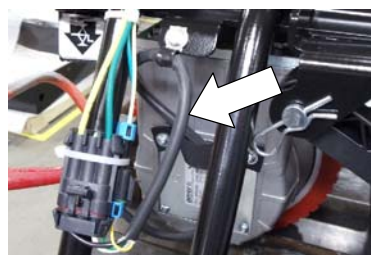
AFTER serial number:
10518138 / T7xxx05315 (Europe)

Equipped with a High Flex Brake Jumper Harness.

The brake wires are secured to the gearbox as shown below.

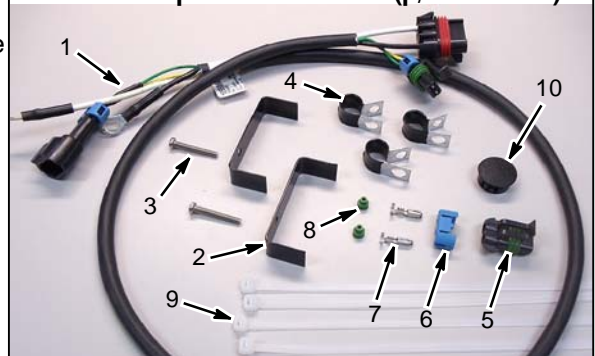
Brake Jumper Kit Contents (p/n 9008400)

Part No.	Description	Qty.
1) 1065808	Harness, Motor, Brake (high flex jumper)	1
2) 1064972	Bracket, Cord	2
3) 33931	Screw, Pan, Phl, M4 x 0.70 x 30, ss	2
4) 140300	Clamp, Cable, Stl, 0.5D (Insulated)	3
5) 78950	Connector, Fem, 2CAV, MP280 sealed	1
6) 78952	Lock, Secondary, M/F 2CAV, MP280 sealed	1
7) 25837	Terminal, Fem 20/22GA	2
8) 25830	Seal, Wire 14GA	2
9) 1300773	Tie, Cable, Nyl, 11.0L, .14w	4
10) 130161	Plug, Dust, Brake	1
9008401	Instructions, Kit Installation	1

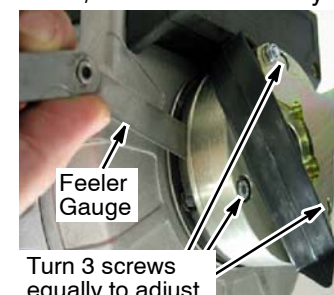
Reminder - Check brake for proper adjustment

With brake installed, measure air gap as shown below. Air gap should measure between .008 in / .20 mm and .012 in / .31 mm all the way around.
