Technical Service Bulletin

MODEL(S) T300e Walk-behind Scrubber
AFFECTED:

SUBJECT: Defective User Interface Circuit Board (PCB). While machine is on charge, the charger interlock function fails to disable the vacuum system. If the squeegee assembly is inadvertently lowered to the floor while the machine is charging, the vacuum motor will activate and could over discharge the batteries resulting in damage if left unnoticed after an extended period. In this situation, the charger is unable to properly function.

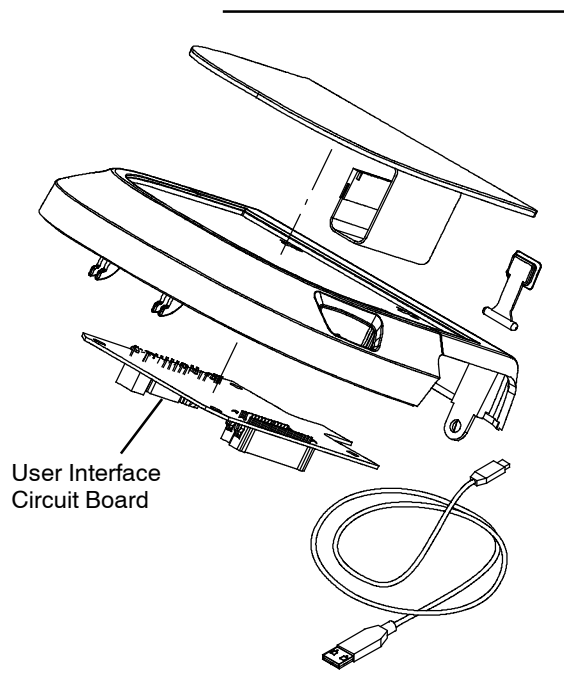
T300e Bezel Kit Contents

User Interface
Circuit Board*Propel model bezel kit shown*

PURPOSE: To repair the defective circuit board, order the following bezel kits.
