Technical Service Bulletin

MODEL(S) T7 Rider Scrubber (disk model)
AFFECTED:

SUBJECT: Potential water leak at solution valve. When scrub deck is raised, the machine's wire harness located above the solution valve may come in contact with the valve causing it to disassemble as shown below. The solution valve is designed to disassemble to allow different orientations by turning the valve body.

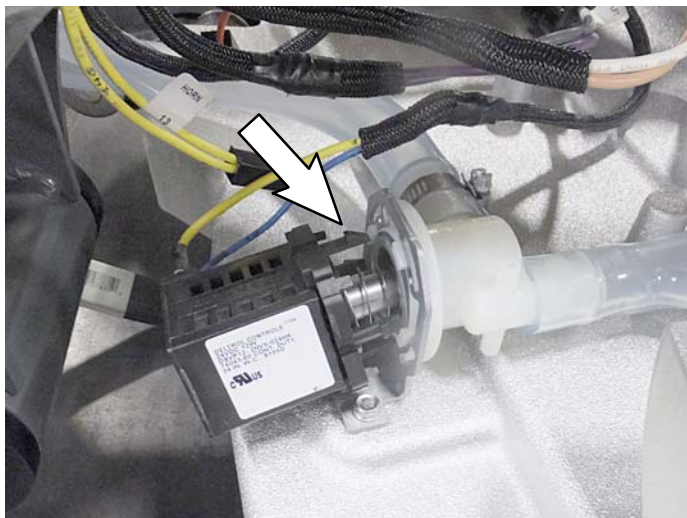
Solution valve disassembled.

PURPOSE: To prevent the above condition, the machine's wire harness should be cable-tied to the machine frame as described below to allow clearance for the solution valve when scrub deck is raised.
