Technical Service Bulletin

MODEL(S) AFFECTED: T600/T600e/T600EE Walk-behind Scrubbers

SUBJECT: Squeegee lift mount durability upgrade. Normal wear and tear on the squeegee mount pivot pin and mounting holes may slowly cause the blade pitch to change and eventually affect squeegee performance.

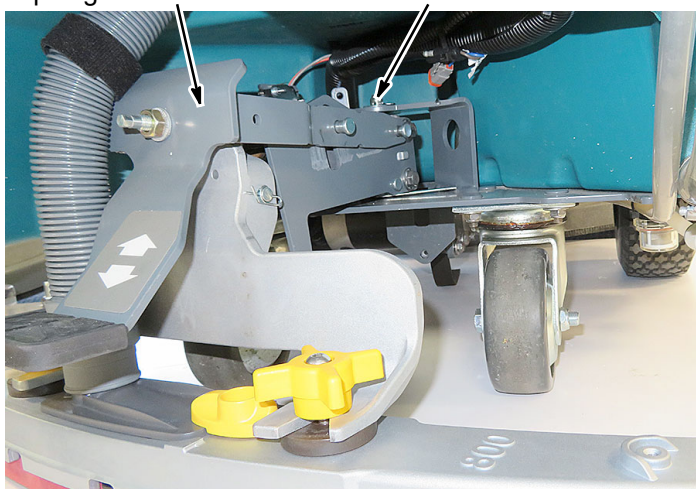
Squeegee Lift Mount

Pivot Pin

Check pivot pin and mounting holes in frame for wear (i.e. deep grooves in pin and elongated holes). Install the upgrade kit if unable to maintain proper blade roll-out using the blade pitch adjustment as described below. If the adjustment stem is near full adjustment (less than 1 stem rotation remaining) with proper blade roll-out, install kit.

PURPOSE: For customers that have experienced the above condition, install the Squeegee Mount Upgrade Kit p/n 9020916. The upgrade kit is designed with flange bushings to protect pin and frame from wear.

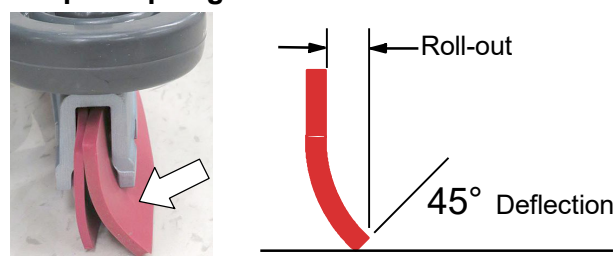
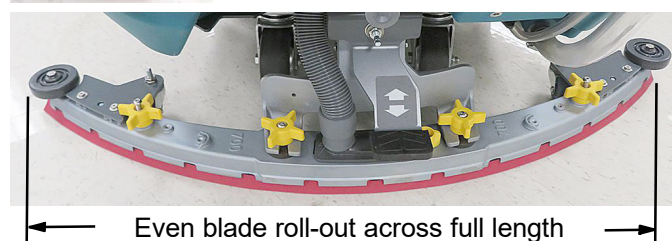
Proper Squeegee Blade Roll-out

Blade Pitch Adjustment: Turn the pitch adjustment stem counter-clockwise to raise blade tips or clockwise to lower the blade tips. 7mm & 17mm wrenches required.
