No. 211

Date: March 18, 2016

Technical Service Bulletin

MODEL(S) AFFECTED: Speed Scrub 300 (SS300) and Speed Scrub 17-20 (SS3) Single Disk Models with 3-lug drive hub design.

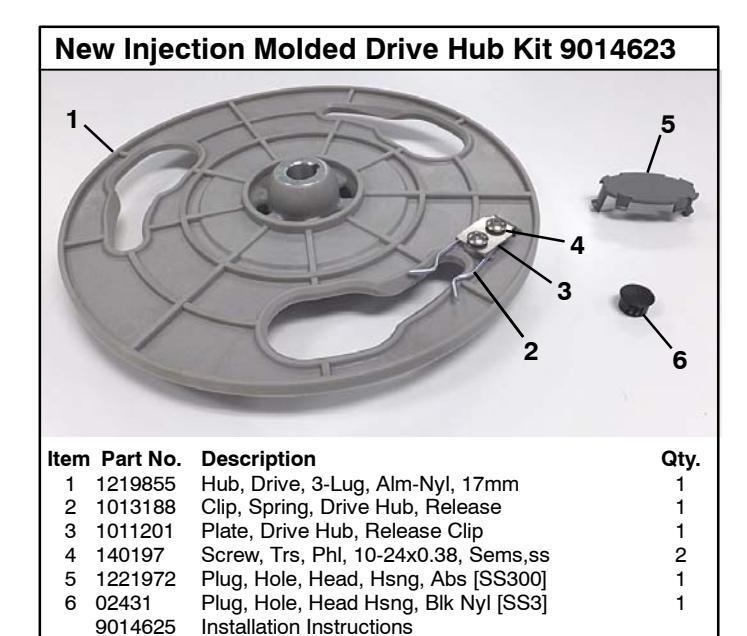
Speed Scrub 300 (SS300) Model

The use of a stop pin to assist in disk removal, shown below, is not required with the new injection molded drive hub and is recommended to be removed. The two hole plugs included in kit (items 5 and 6) are intended to cover the stop pin opening after removing pin.
