Technical Service Bulletin

MODEL(S) AFFECTED: Speed Scrub 300 Walk-Behind Scrubber

Models manufactured between S/N SS300-10885160-10894861

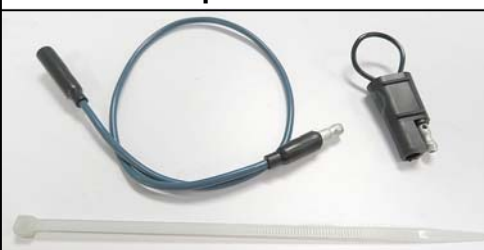
9017921 Jumper Kit Contents

* The kit contents will include either a wire harness jumper or a plug connector jumper as shown above. Both serve the same purpose.

Install Jumper Kit to repair issue:
