Technical Service Bulletin

MODEL(S) **M17/T17**
AFFECTED:

SUBJECT: Sweep or scrub motor short fault caused by improper brush pattern and/or excessive brush wear or debris caught in brush.

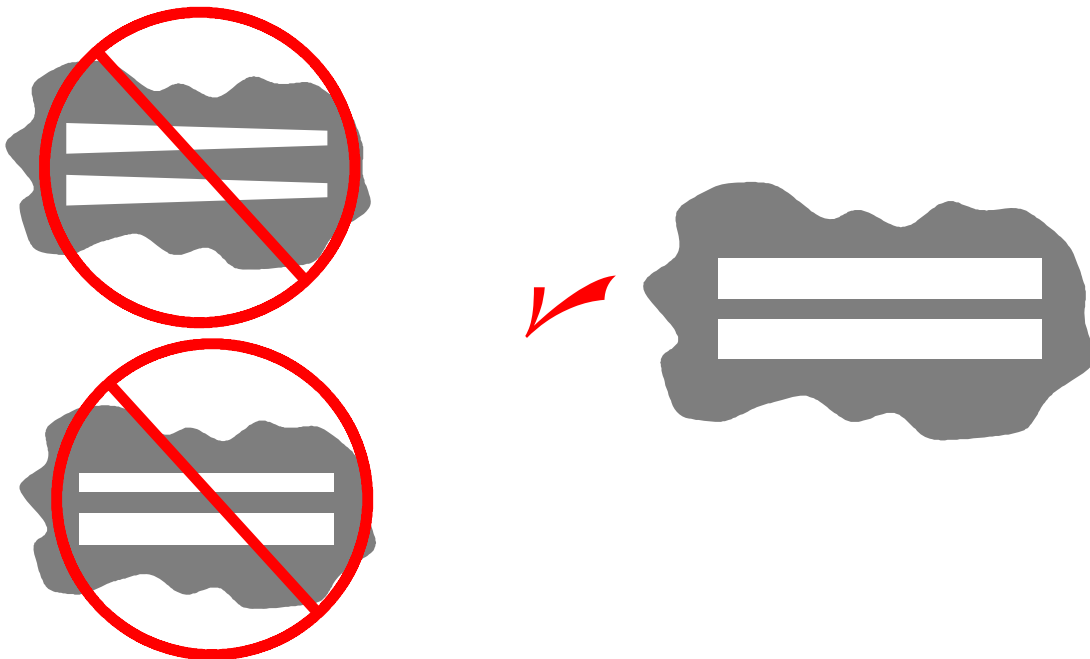
Check sweeping/scrubbing main brushes for excessive wear/obstructions and check/adjust brush patterns before further troubleshooting harness and sweep/scrub brush motors.
