FaST Injector Assembly Conversion Kit

Models: T3 w/ FaST, Speed Scrub 17"-20" w/ FaST

This kit is intended for models manufactured before serial number 10346875, date code July 17, 2007. The purpose of this kit is to upgrade early models with improved FaST Injector Assembly.

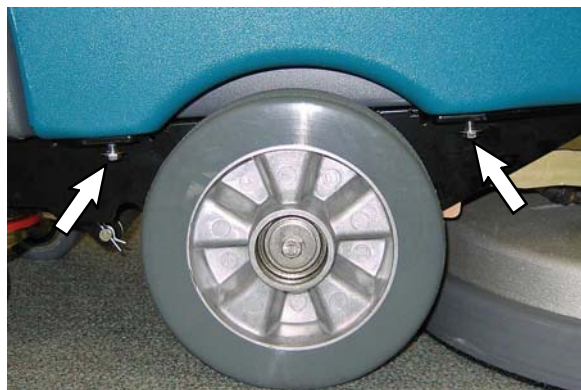
Fig. 1

a.) If equipped, remove the four screws that mount the shroud to the chassis (Figure 1).

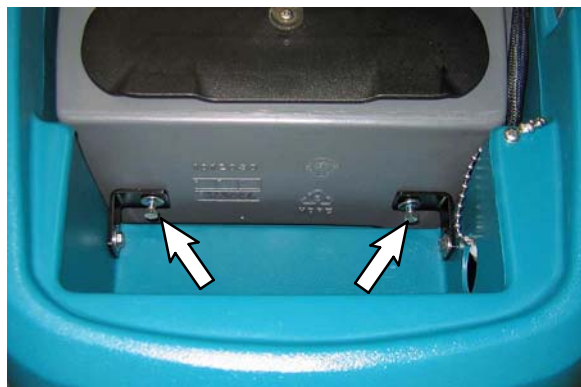
Fig. 2

b.) Remove the two screws that mount the front of the shroud to the solution tank (Figure 2).

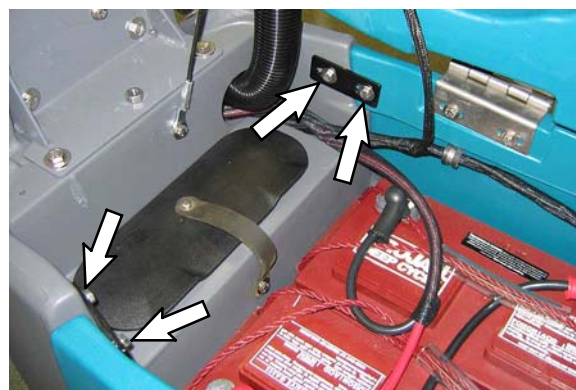
Fig. 3

- c.) Loosen the four screws that mount the rear of the shroud to the solution tank (Figure 3). DO NOT REMOVE SCREWS.

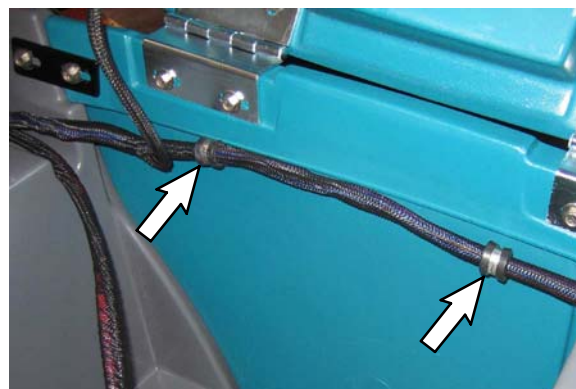
Fig. 4

- d.) Remove the two clamp screws that mount the wire harness to the shroud (Figure 4).

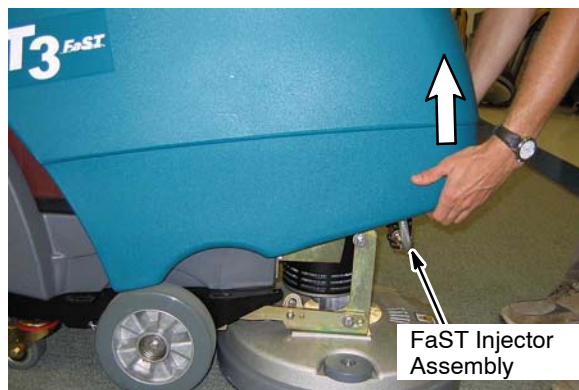
Fig. 5

e.) Lift the front of the shroud to access the FaST injector assembly (Figure 5). For later models, pull shroud forward then lift.

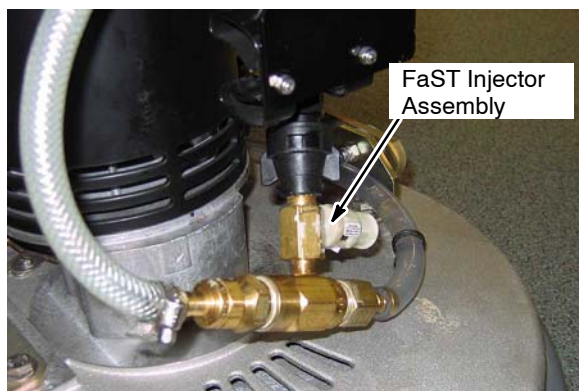
Fig. 6

2. Remove the old FaST Injector Assembly from the machine (Figure 6).

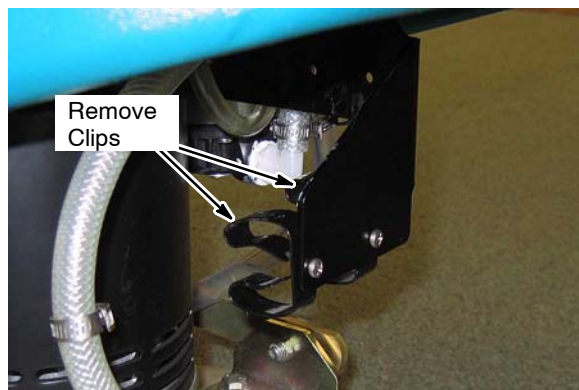
Fig. 7

3. Remove the two clips from the injector mounting bracket (Figure 7).

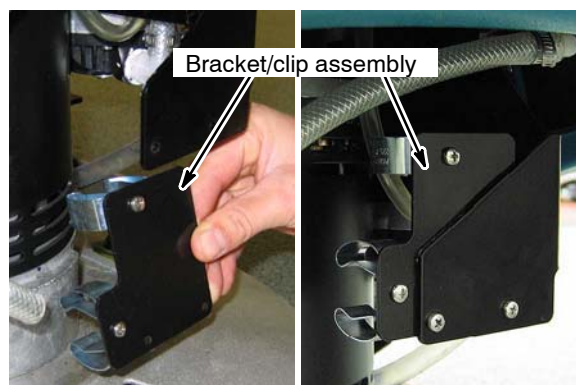
Fig. 8

4. Install the retrofit bracket/clip assembly supplied with kit (Figure 8).

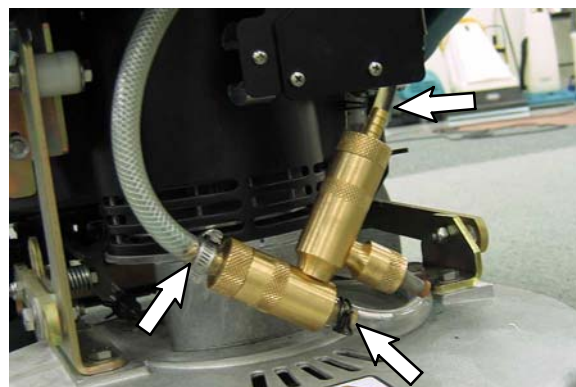
Fig. 9

5. Reconnect to hoses to the new FaST Injector Assembly as shown (Figure 9).

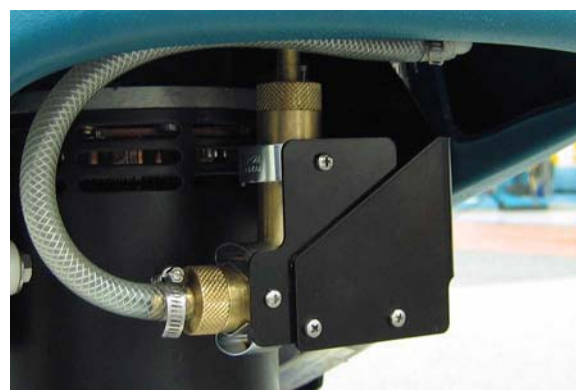
Fig. 10

6. Attach the new FaST Injector Assembly into the clips as shown (Figure 10).
