Technical Service Bulletin

MODEL(S) AFFECTED: **Tennant T3 Scrubber Dryer** (Models manufactured before mid November, 2005.)

SUBJECT: Recovery tank drain hose damage.

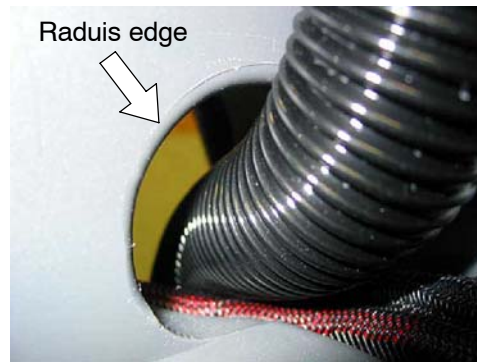
AFTER

Using a round file or dremel, carefully add a 1/4" radius to the upper edge of the passage as shown below. This will allow the drain hose to slide freely through the passage when the recovery tank is lifted up and down.

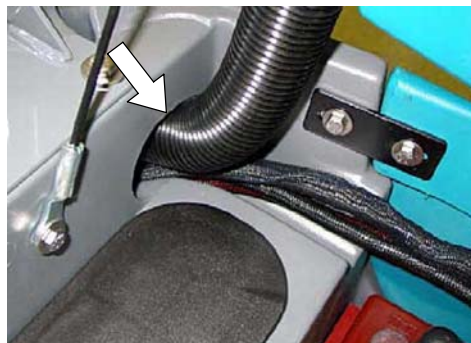
PURPOSE: To prevent drain hose damage, the removal of rotomold material is required as described below.
