Technical Service Bulletin

**MODEL(S)
AFFECTED:****Tennant T7 Rider Scrubber**

SUBJECT:

Potential accelerator pedal failure. Although this has occurred in less than 0.1% machines, Tennant mandates immediate machine repairs.

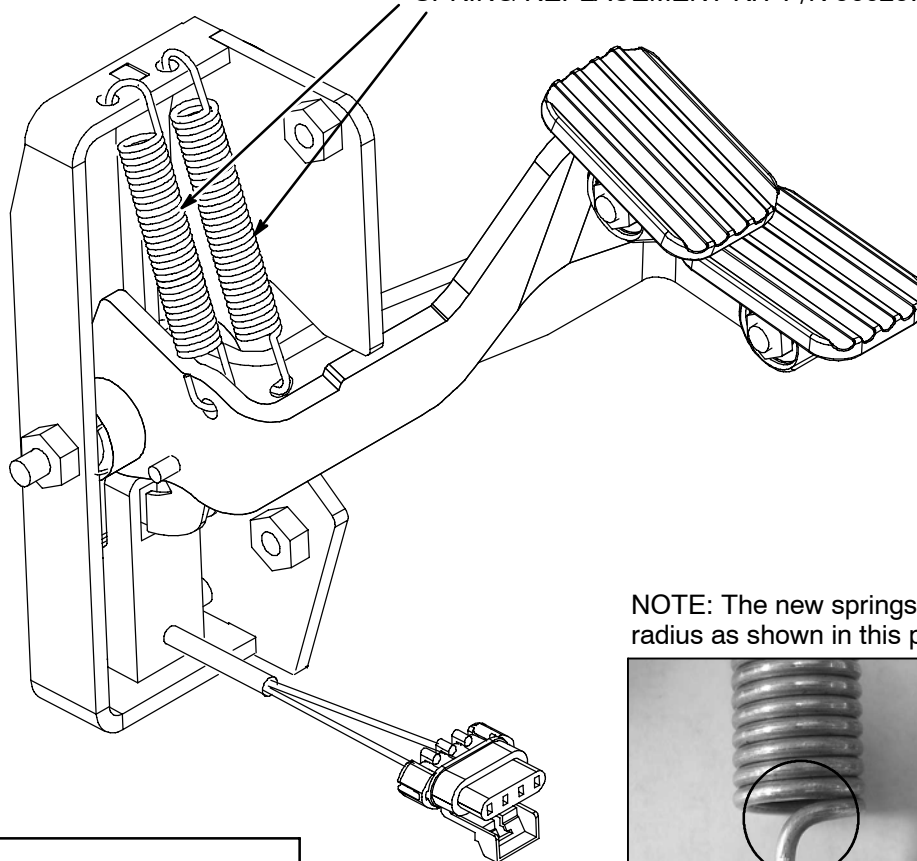
DISPOSE EXISTING SPRINGS AND INSTALL
SPRING REPLACEMENT KIT P/N 9002672

NOTES:9002672 - Kit, Accelerator and Brake Pedal Spring Replacement - Kit includes 2 springs and installation instructions. Kit and installation expense will be covered by Tennant.

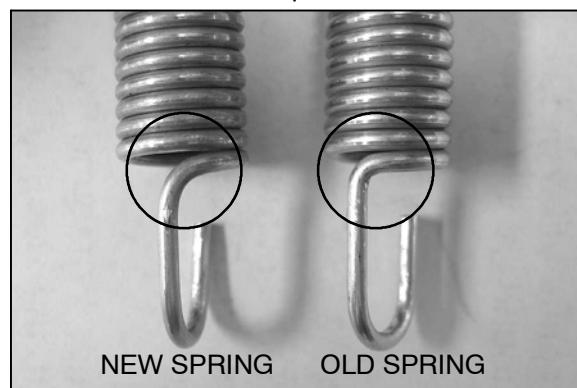
NOTE: The new springs have a larger bend radius as shown in this photo.
