Technical Service Bulletin

MODEL(S) AFFECTED: S9 Walk-Behind Sweeper
Machines manufactured before July, 2014.

SUBJECT: Rear brush linkage rattling sound.

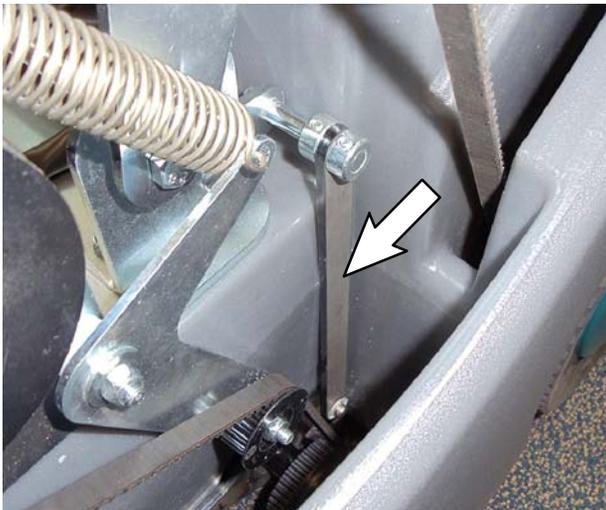
Left side rear brush linkage

PURPOSE: If you experience this condition, order the Rear Brush Linkage Upgrade Kit p/n 9013049. The upgrade kit includes new link arms equipped with nylon flange bushings to resolve rattle issue.

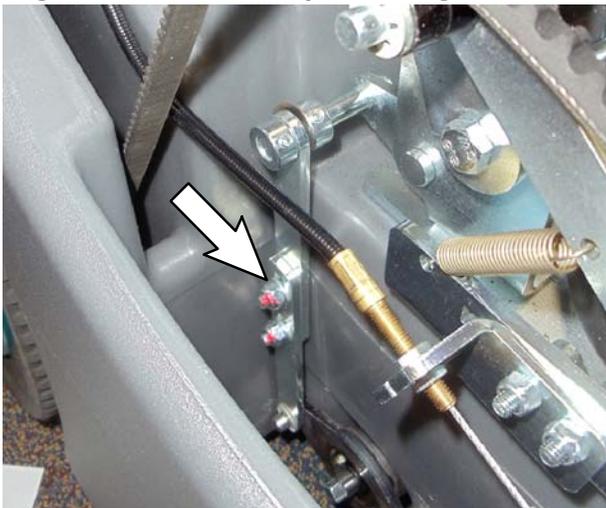
Right side rear brush 2-piece linkage
