# Technical Service Bulletin

**MODEL(S) AFFECTED: T500/T500e Walk-behind Scrubber**

**SUBJECT:** Potential drive wheel mounting hardware issue. The axle nut may back off and cause the wheel to become loose and possibly damage wheel and axle.

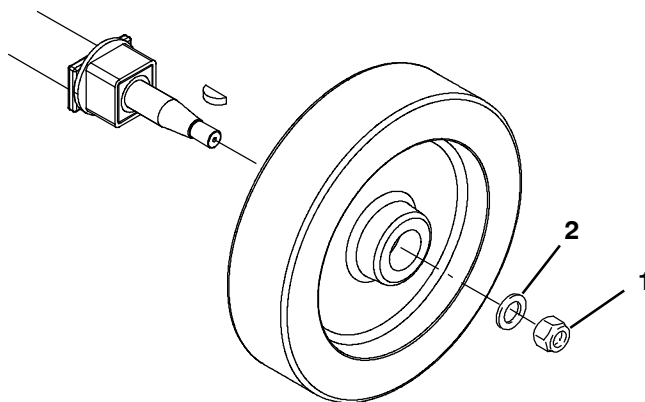
Ref.	Part No.	Description
1	09741	Nut, Hex, Lock, M12 x 1.75, NL, SS
2	140058	Washer, Flat, 0.54b 0.88d .06, SS

Maximum torque 24 Nm/18 ft-lbs. Do not over tighten nut. Higher torques will deform the center of the wheel, compromising the conical fit to the transaxle.

**PURPOSE:** To prevent axle nut from backing off, install improved hardware listed below.
