# Technical Service Bulletin

**MODEL(S) AFFECTED:** **T390 Walk-Behind Floor Scrubber**  
Machines manufactured before serial number 1255469-00496 (July 07, 2021)

**SUBJECT:** Squeegee height adjustment may be required if end of squeegee blade is touching floor when raised to transport position as shown below.

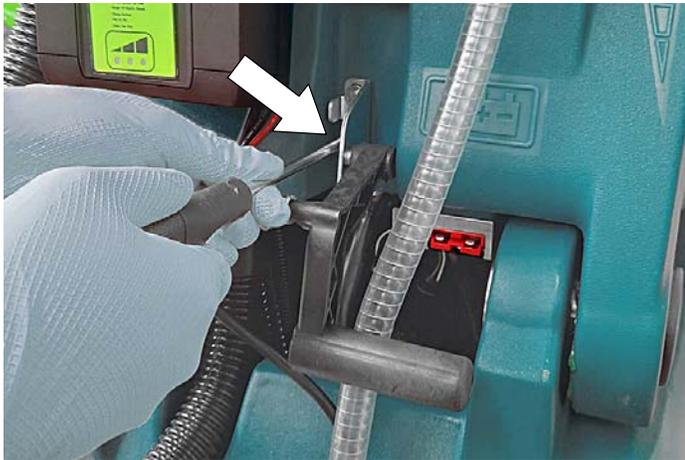
Adjust squeegee lift handle bracket

1. Lower the squeegee assembly to the floor.
2. Using an 8mm socket wrench, loosen the two m5 screws securing the lift handle bracket.
3. Adjust the lift handle bracket slightly upward and re-tighten the two screws.
4. Lift the squeegee assembly to the transport position and ensure the squeegee blades are no longer touching floor.
